--SAWMILL POND DAM --
PHASE I
INSPECTION / EVALUATION REPORT

Dam Name: SAWMILL POND DAM
National ID No.: MA00098
Owner: TOWN OF BROOKFIELD, MA
Town: BROOKFIELD, MA
Consultant: LENARD ENGINEERING, INC.
Date of Inspection: JULY 20, 2021

EXECUTIVE SUMMARY

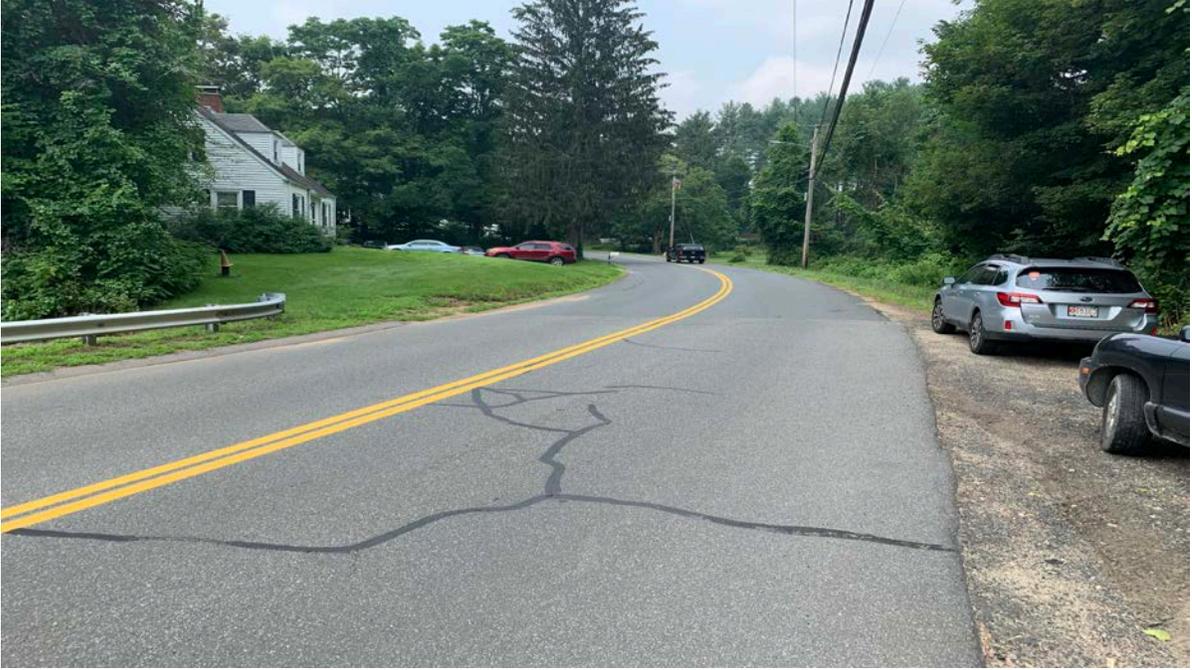
Photograph 1: Left abutment viewed from the crest. Lake Road passes directly over the left abutment.

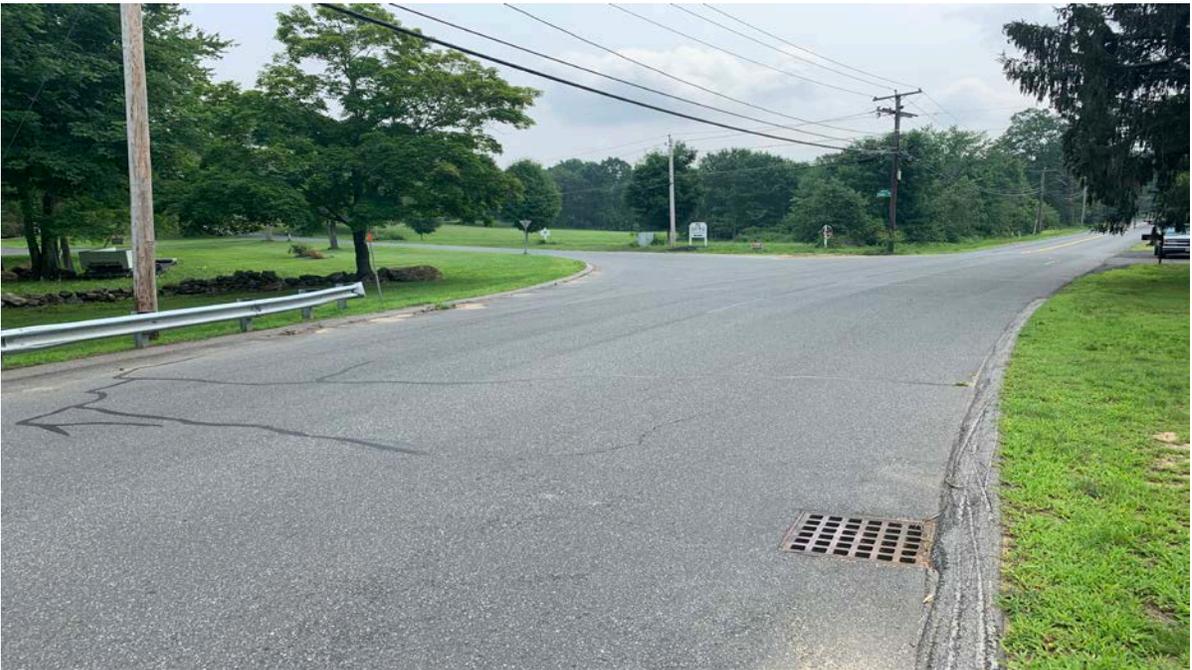
Photograph 2: Right abutment viewed from the crest. Lake Road passes directly over the right abutment.

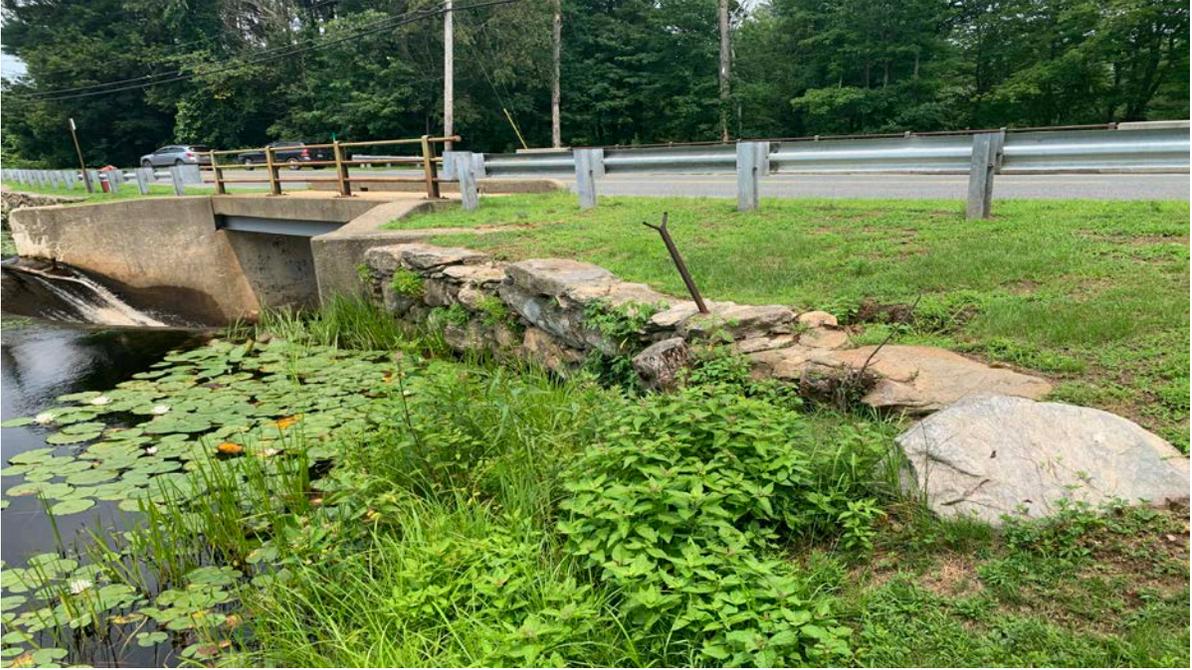
The right upstream stone masonry wall was missing stones at its base and along its cap and is leaning outward toward the impoundment. See Photograph 3.

Photograph 3: Right upstream stone masonry wall and embankment. The right upstream stone masonry wall was missing stones at its base and along its top and was leaning outward toward the impoundment. There was some minor brush growing through the wall.

- A. Repair/replace the low level outlet with an accessible operator;
- B. Repair/replace right upstream stone masonry wall.

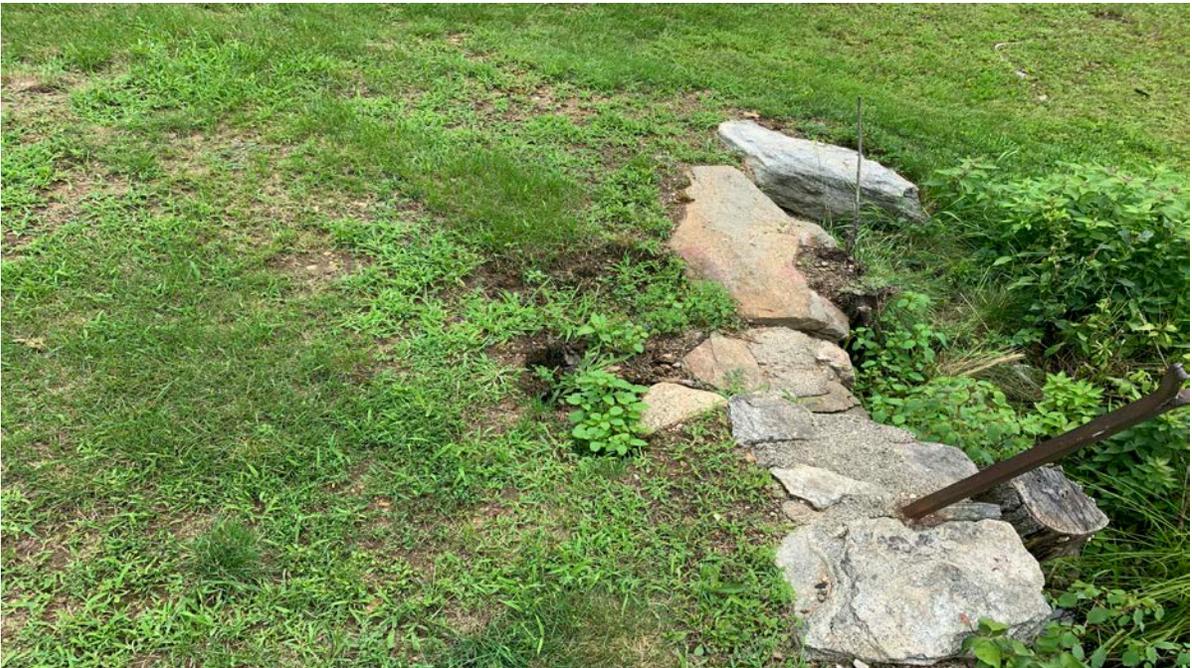
A small sunken area with a rotted stump was observed on the upstream side of the right dam crest directly behind the stone masonry wall. The sunken area was in close proximity to an old CMP drain pipe that drained through the masonry wall and back into the pond. It is unknown if the area was related in any way to the old drain line below. See Photographs 4.

Photograph 4: Right upstream stone masonry wall and embankment. A small sunken area was observed behind the upstream stone masonry wall to the right of the spillway.

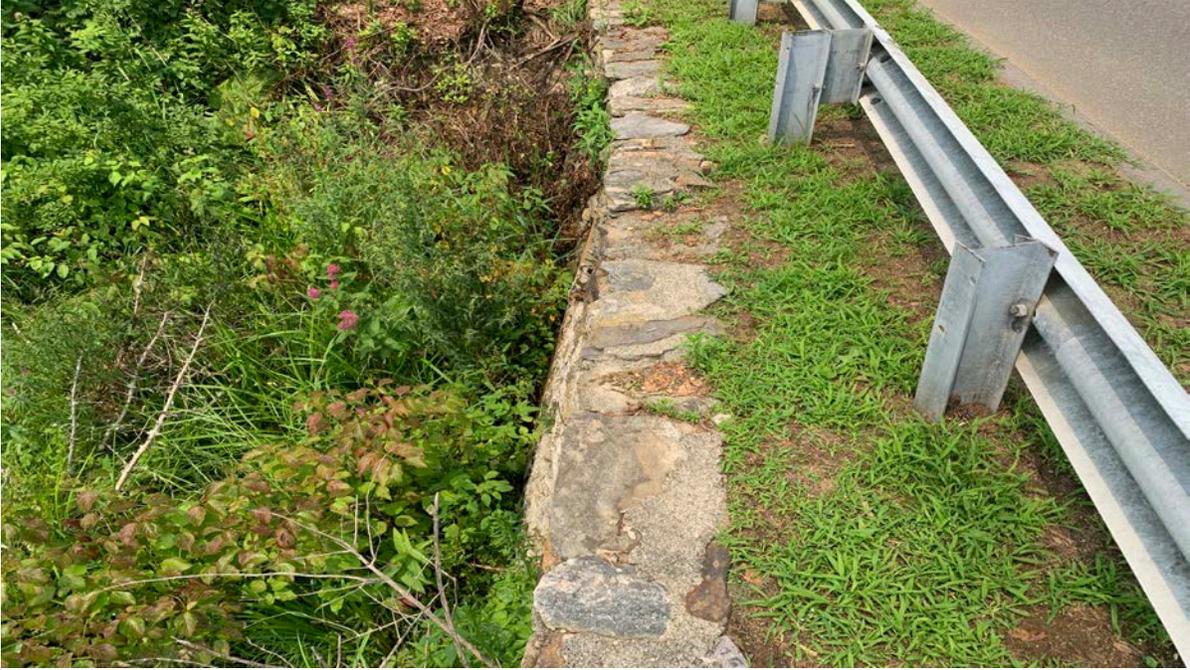
The left upstream stone masonry wall was missing cap stones in some locations but overall appears to be in good condition. See Photograph 5.

Photograph 5: Left upstream stone masonry wall looking toward the left abutment. The wall was missing cap stones in multiple areas.

- A. Continue to maintain and clear dam of trees within 20 feet of the dam; do not remove stumps, apply herbicide; monitor stumps for decay and properly fill when voids are created;
- B. Replace cap stones along left stone masonry wall;
- C. Install public safety fences and signs as described in Section 2.5.

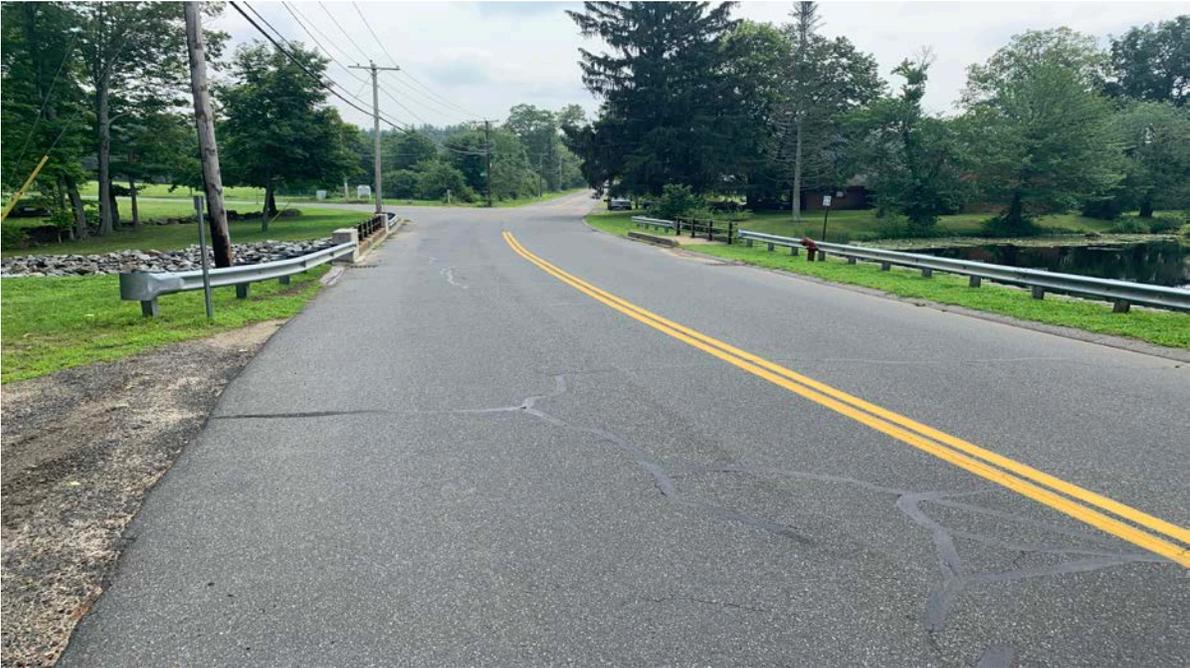
The crest of the road was in good condition with minor cracks. The asphalt had been replaced since the last inspection. See Photograph 6.

Photograph 6: Minor cracking was observed in the asphalt paved crest. Photo was taken from the left abutment to the right abutment.

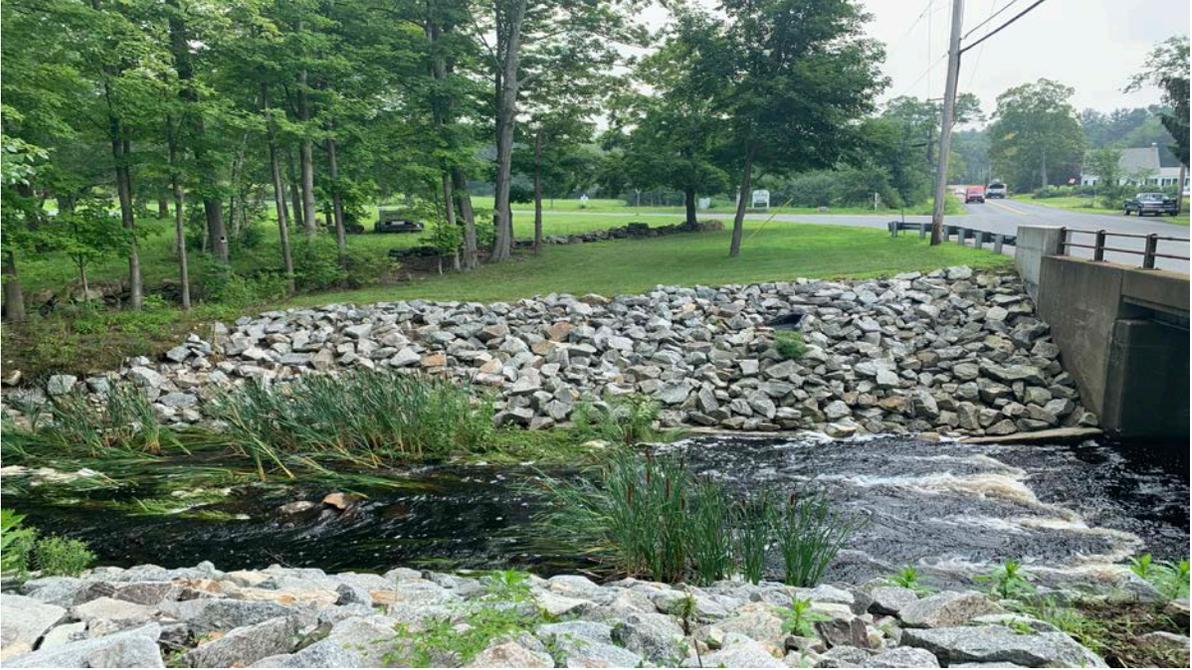
Photograph 7: Right downstream dam embankment and channel slope.

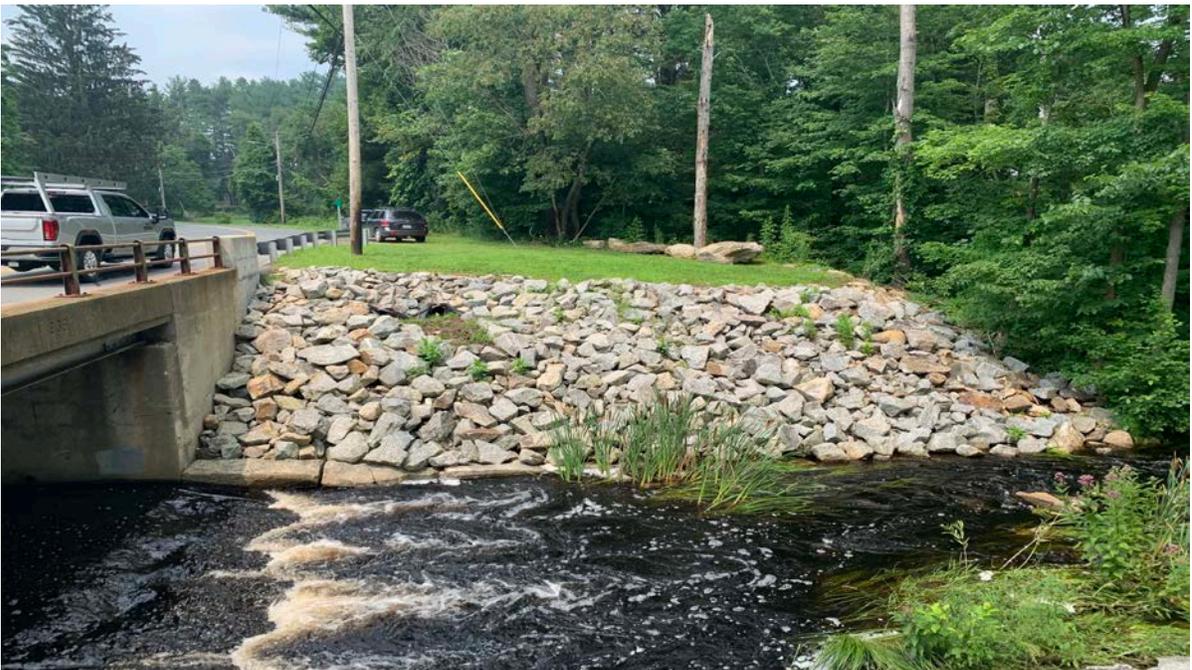
Photograph 8: Left downstream dam embankment and channel slope. A gravel parking area was located on the earthen embankment near the left abutment.

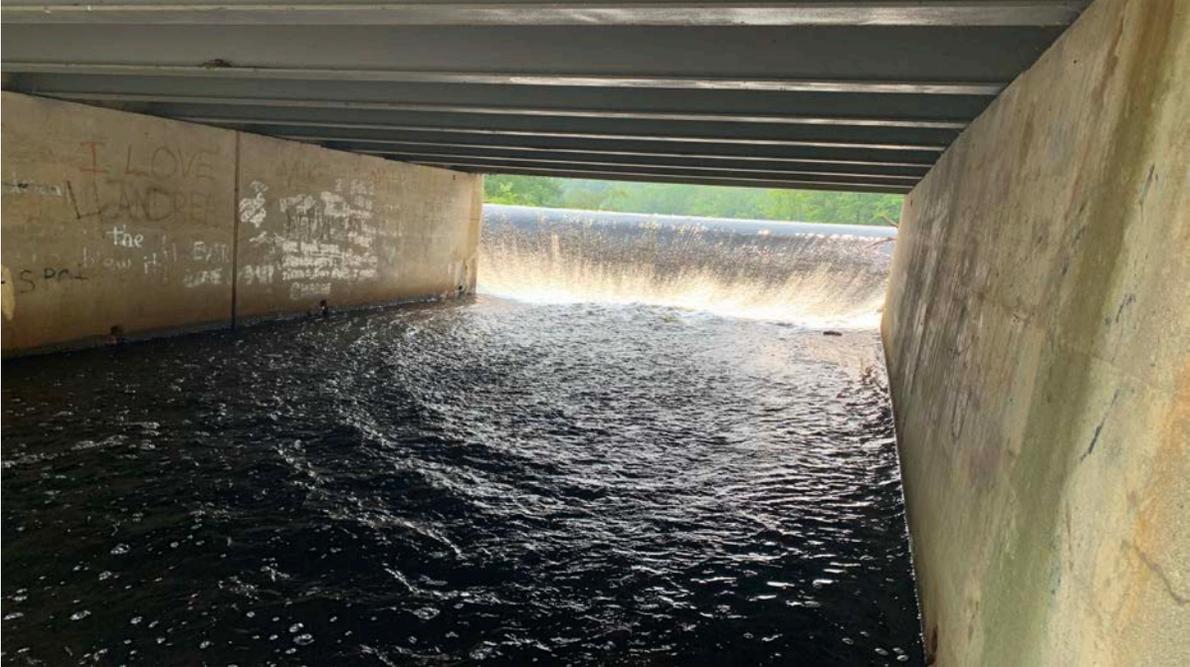
Photograph 9: View under bridge from downstream side. Weep holes were observed at the base of the bridge abutments that also serve as the spillway training walls.

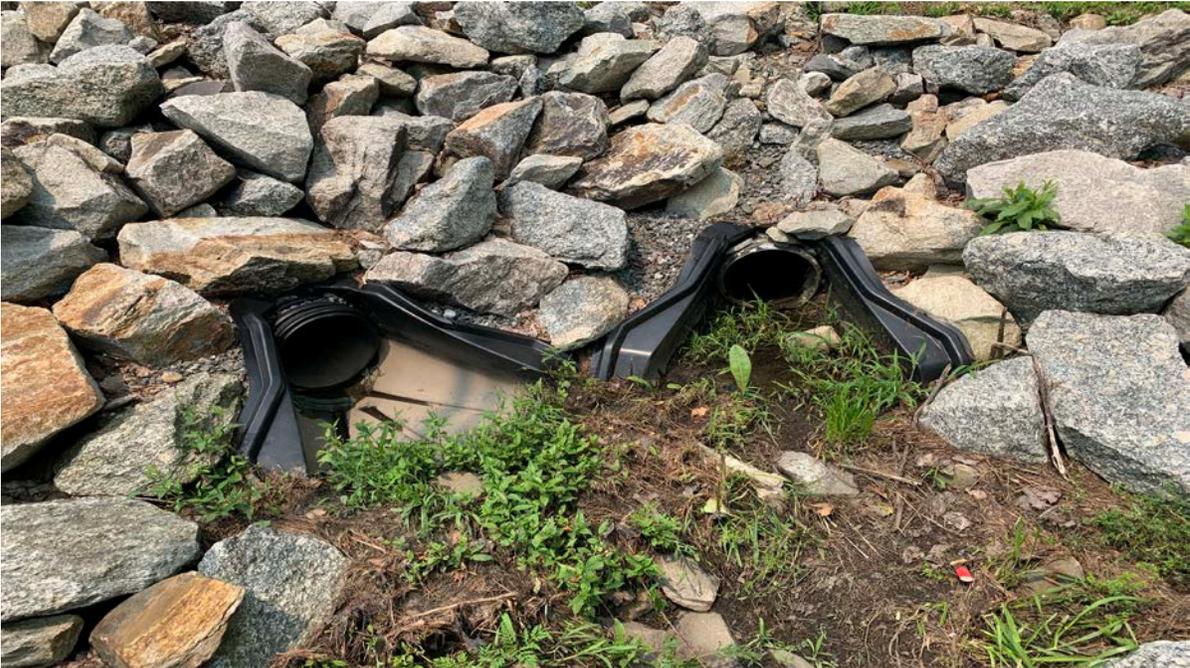
Photograph 10: Left downstream channel slope. Photo shows discharge (left flared end) location of 2 left most catch basins on Lake Road that drain to the downstream side of the dam and through the left channel slope. The flared end shown to the right is the discharge location from a catch basin located further up Lake Road to the left of the dam. Pipes are a 12" HDPE (left) and a 12" CMP (right).

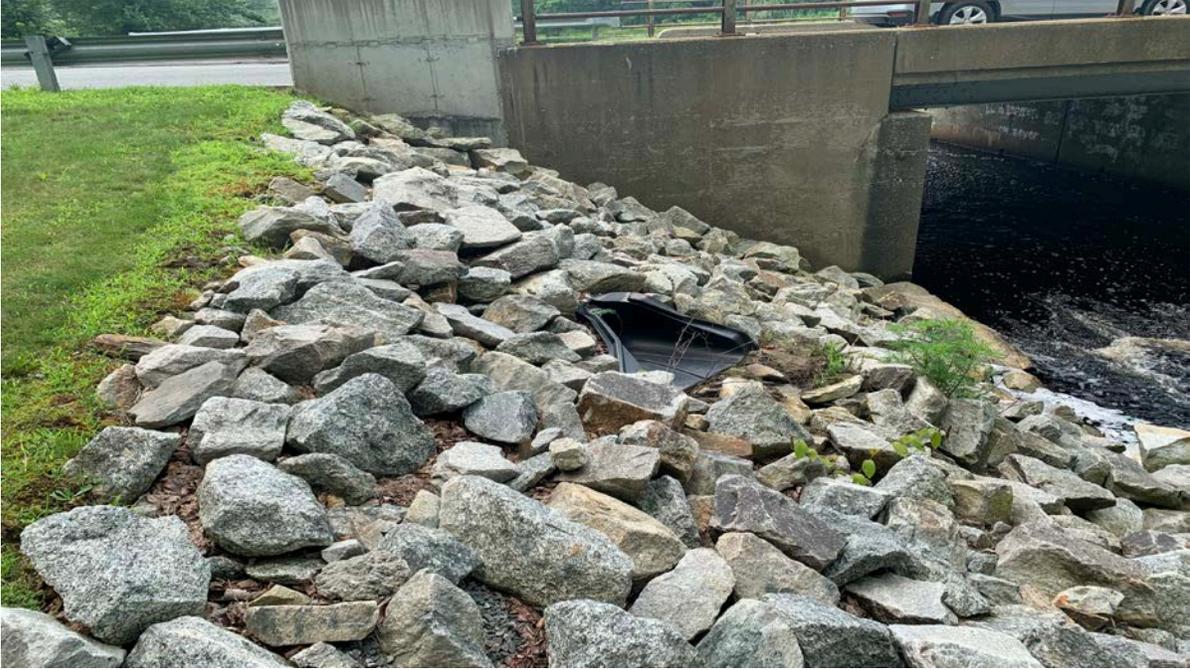
Photograph 11: Right downstream channel slope. Photo shows discharge location of 2 right most catch basins on Lake Road that drain to the downstream side of the dam and through the right channel slope. Pipe is a 12" HDPE

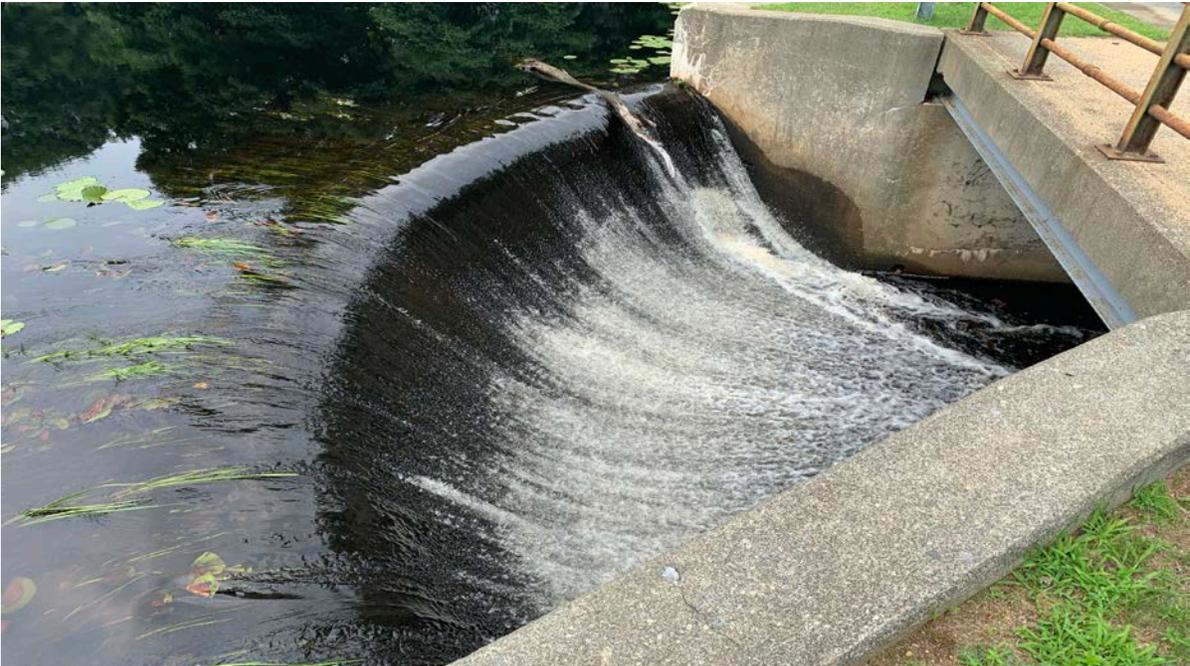
Minor debris was observed stuck on the spillway crest prior to the bridge. See Photograph 12.
- **Low-Level Outlets**

Photograph 12: Spillway ogee weir from right crest embankment. Minor debris was observed at the spillway crest.

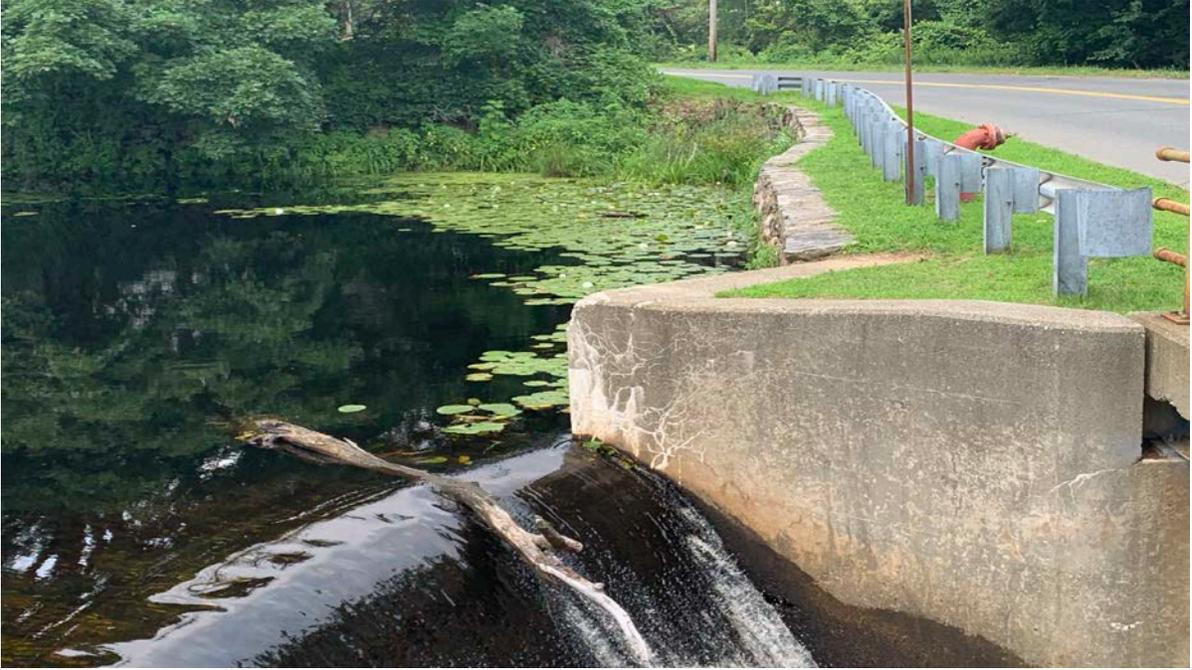
Photograph 13: Left spillway training wall/bridge abutment. Some minor cracking was observed in the left concrete training wall/bridge abutment.

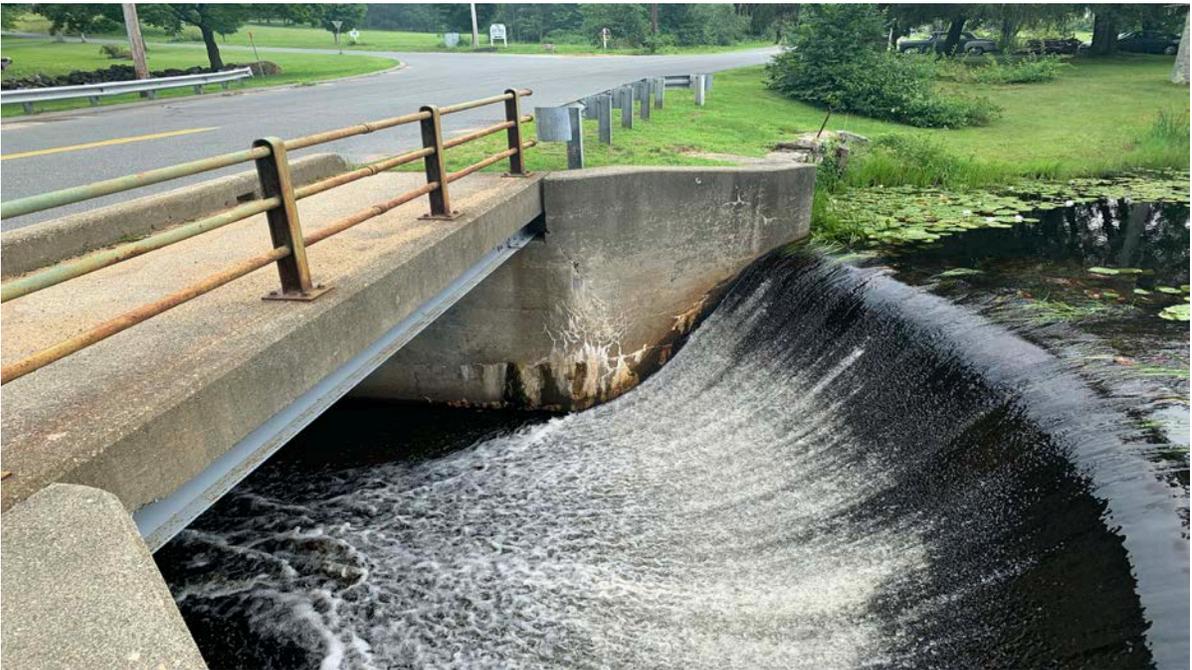
Some minor cracking was observed in the right concrete training walls/bridge abutment along the upstream side. See Photograph 14.

Photograph 14: Right spillway training wall/bridge abutment. Some minor cracking was observed in the right concrete training wall/bridge abutment.

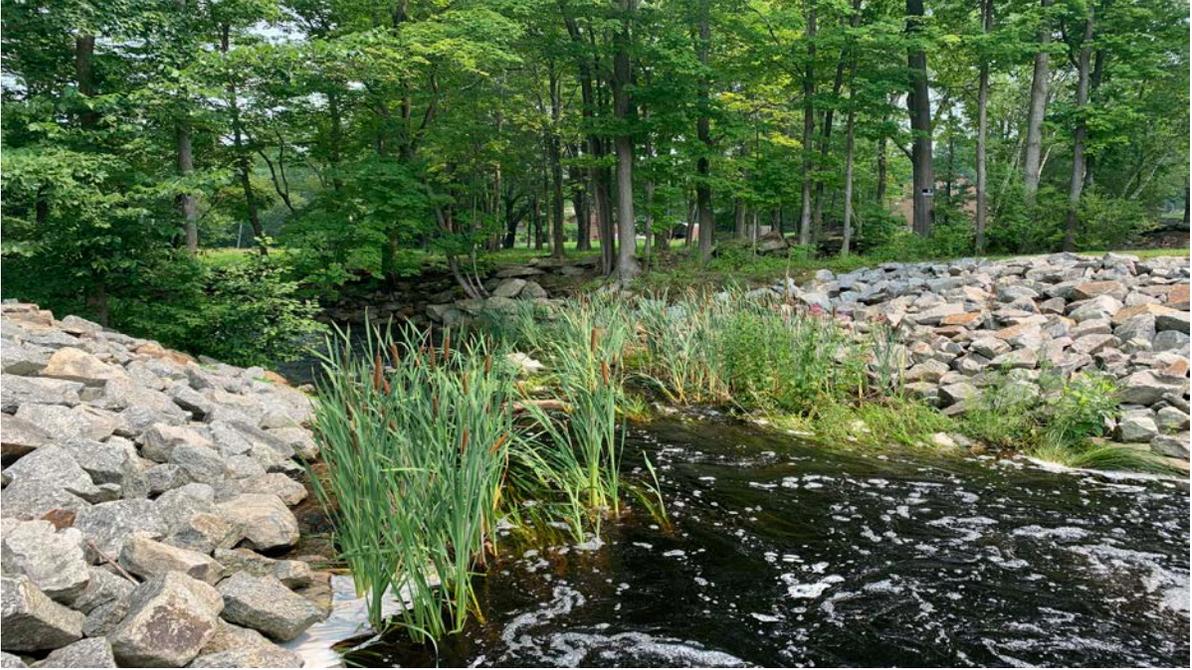
Photograph 15: Downstream area. Vegetation is growing within the channel.
