SECTION 3

3.0 ASSESSMENTS AND RECOMMENDATIONS

TOWN OF BROOKFIELD
 LOCUS PLAN
 SAW MILL POND DAM (NAT. ID # MA00098)

SAW MILL POND DAM - PHASE I INSPECTION REPORT - SITE SKETCH

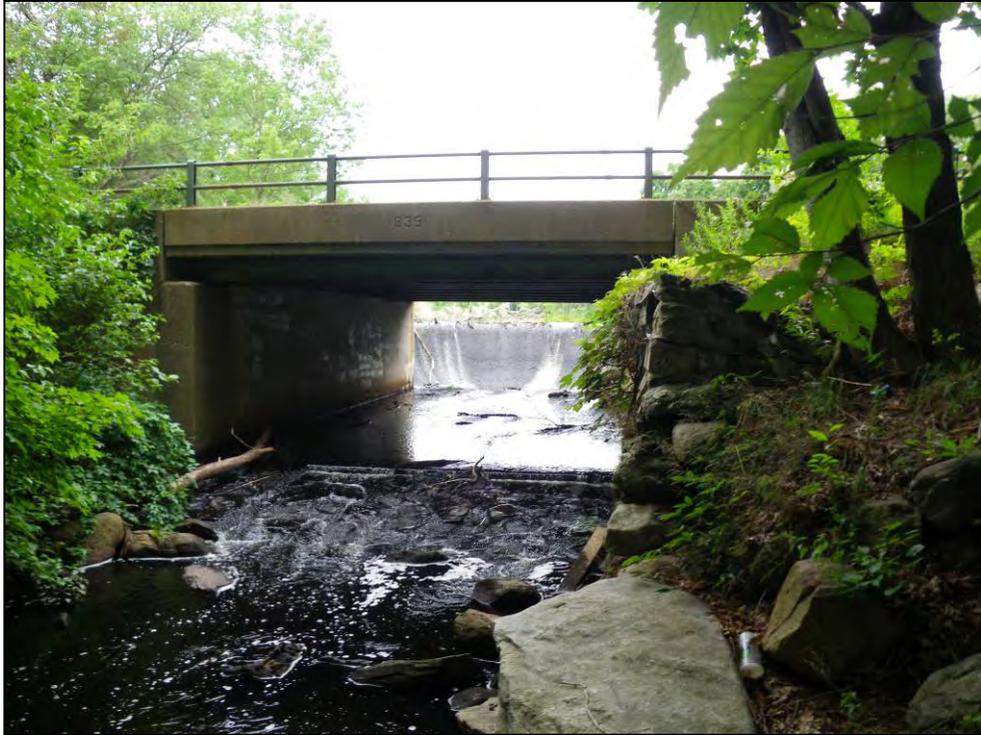
Photo 1: Overview of dam & spillway from downstream channel

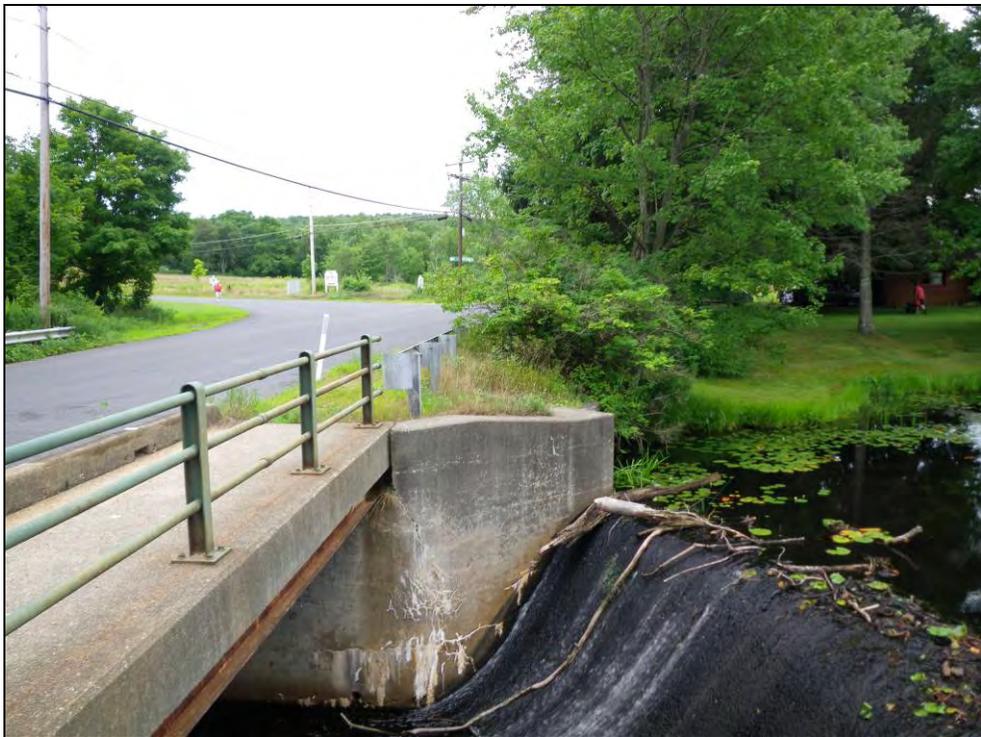
5. Severely deteriorated downstream stone masonry wall, including formation of cracks and undermining of the toe.
6. Vegetation growing from cracks in the upstream stone masonry walls.

Photo 2: Overview of upstream face from left spillway training wall (facing south)

1. Remove woody vegetation from dam embankment and the downstream area within 20 feet of the dam toe.
2. Remove trees and vegetation from upstream stone masonry walls. This should be done in conjunction with the recommended stability assessment and may require a Part A dam safety permit.

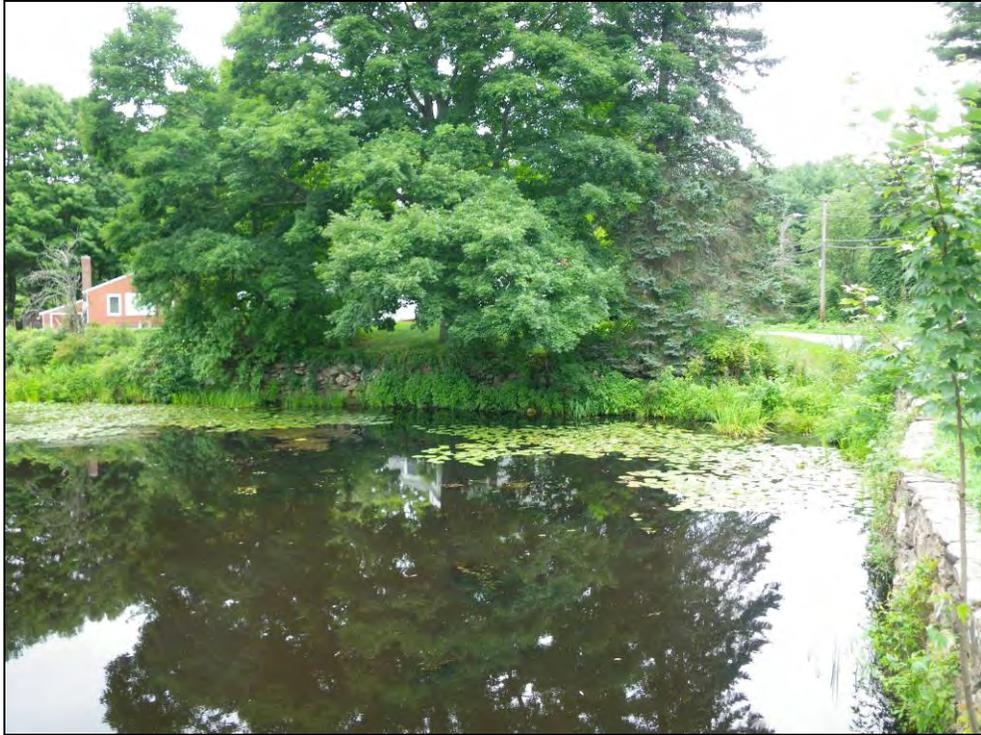
Photo 3: Overview of upstream face from left spillway training wall (facing north)

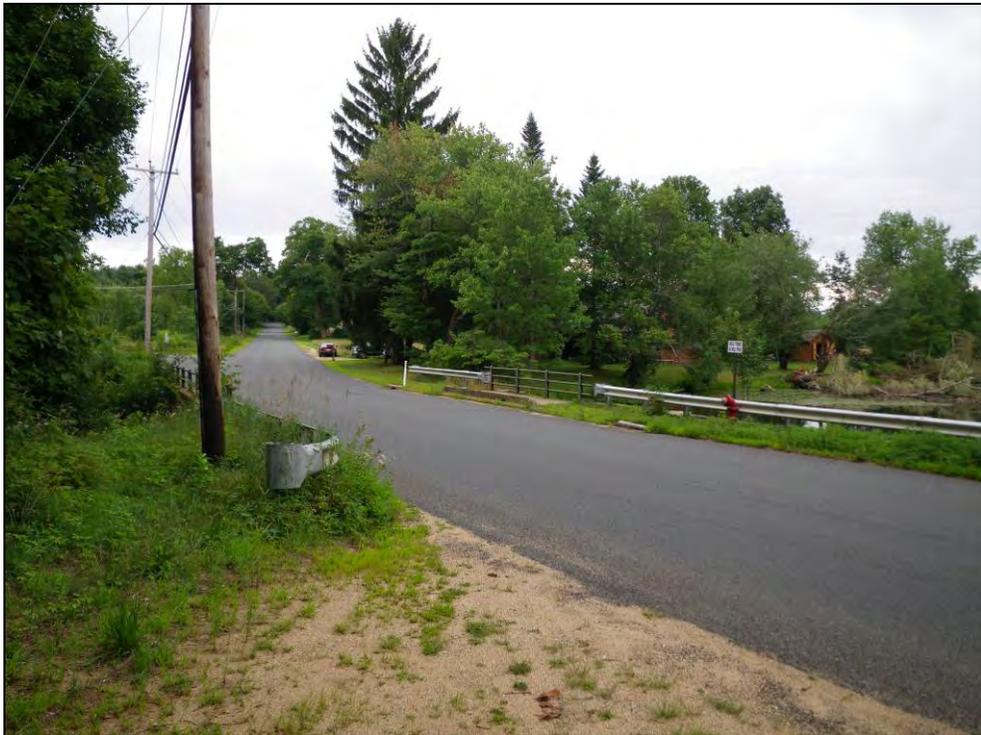
7. Sinkhole on the crest of the Dam in the vicinity of the upstream stone masonry walls where a road-drainage CMP has collapsed.
8. Undulations along portions of the downstream side of the dam crest.

Photo 4: Overview of dam crest from left abutment

3. Re-grade portions of the embankment crest where undulations are present.
4. Establish and maintain a healthy vegetative cover. Grass or other vegetation should be mowed periodically and kept to a height of 3 to 12 inches.

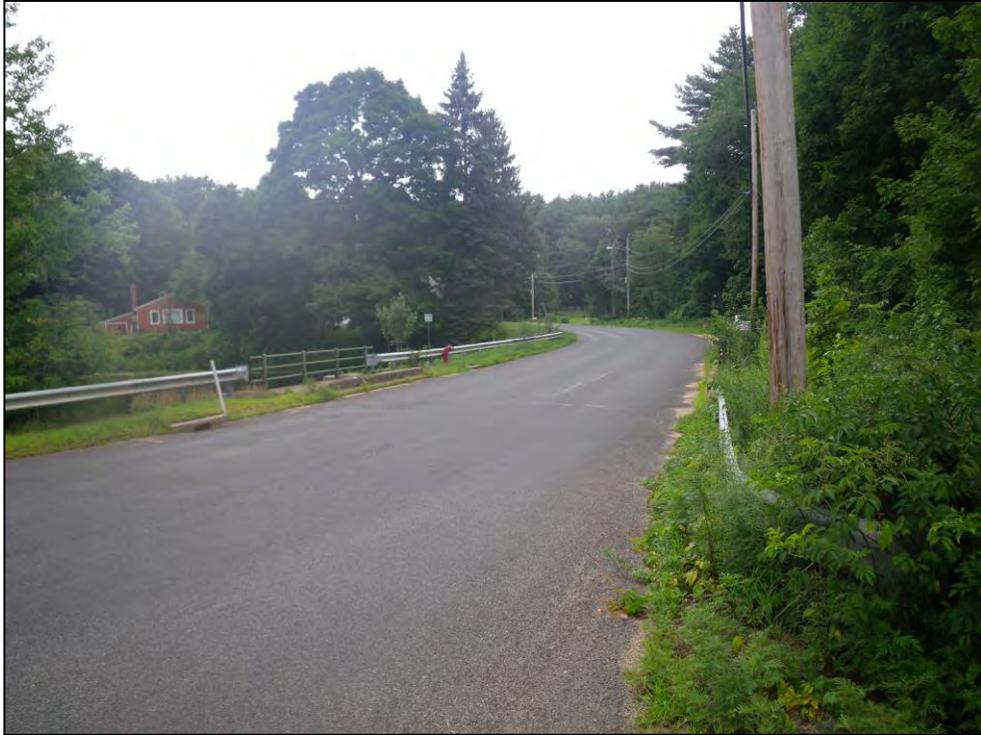
Photo 5: Overview of dam crest from right abutment

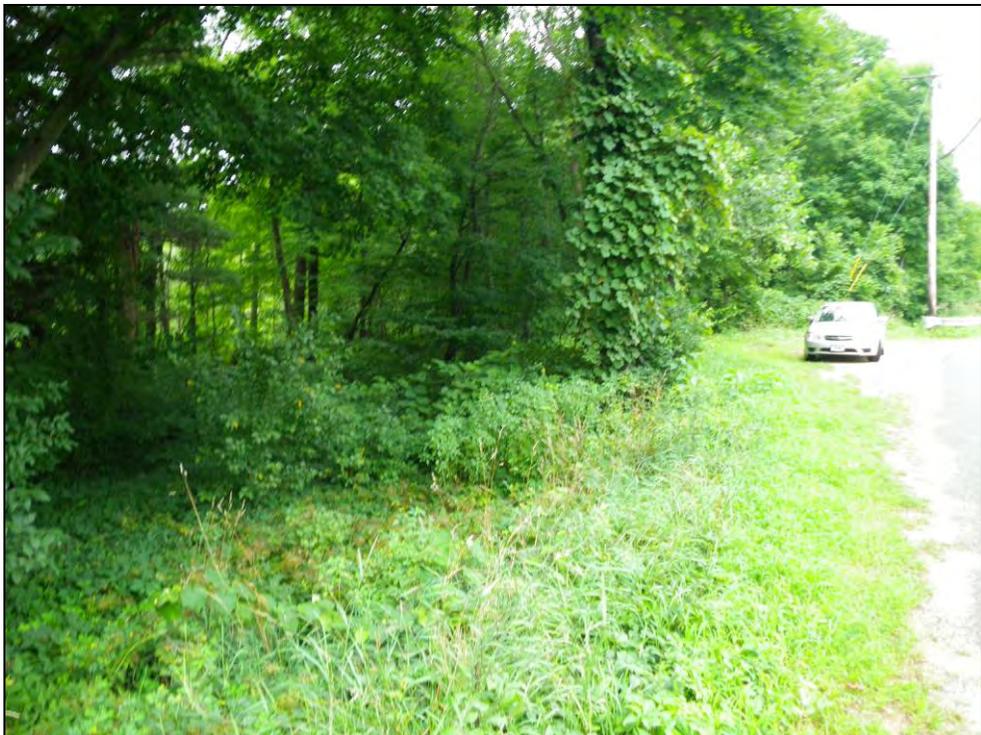
3. Deterioration of the visible portion of the low-level outlet pipe.
4. Dense vegetation, steep slopes, and evidence of sloughing on the downstream face of the dam.

Photo 6: Overview of downstream face from left abutment

1. Remove all trees on the Dam and within 20 feet of toe. Remove stumps and roots, fill and compact voids, and establish vegetative cover.
2. Re-grade steep portions of the downstream face to a slope of 3H:1V or less.
3. Repair or replace the downstream stone masonry wall.
4. Remove CMPs from the dam embankment, repair the sinkhole.
