RE: Follow-up Inspection
Saw Mill Pond Dam MA00098
Brookfield, MA

**Commonwealth of Massachusetts
Department of Conservation and Recreation
Office of Dam Safety Poor Condition Dam
Follow-up Inspection Form**

Dam Name: Saw Mill Pond Dam

Nat. ID Number: MA00098

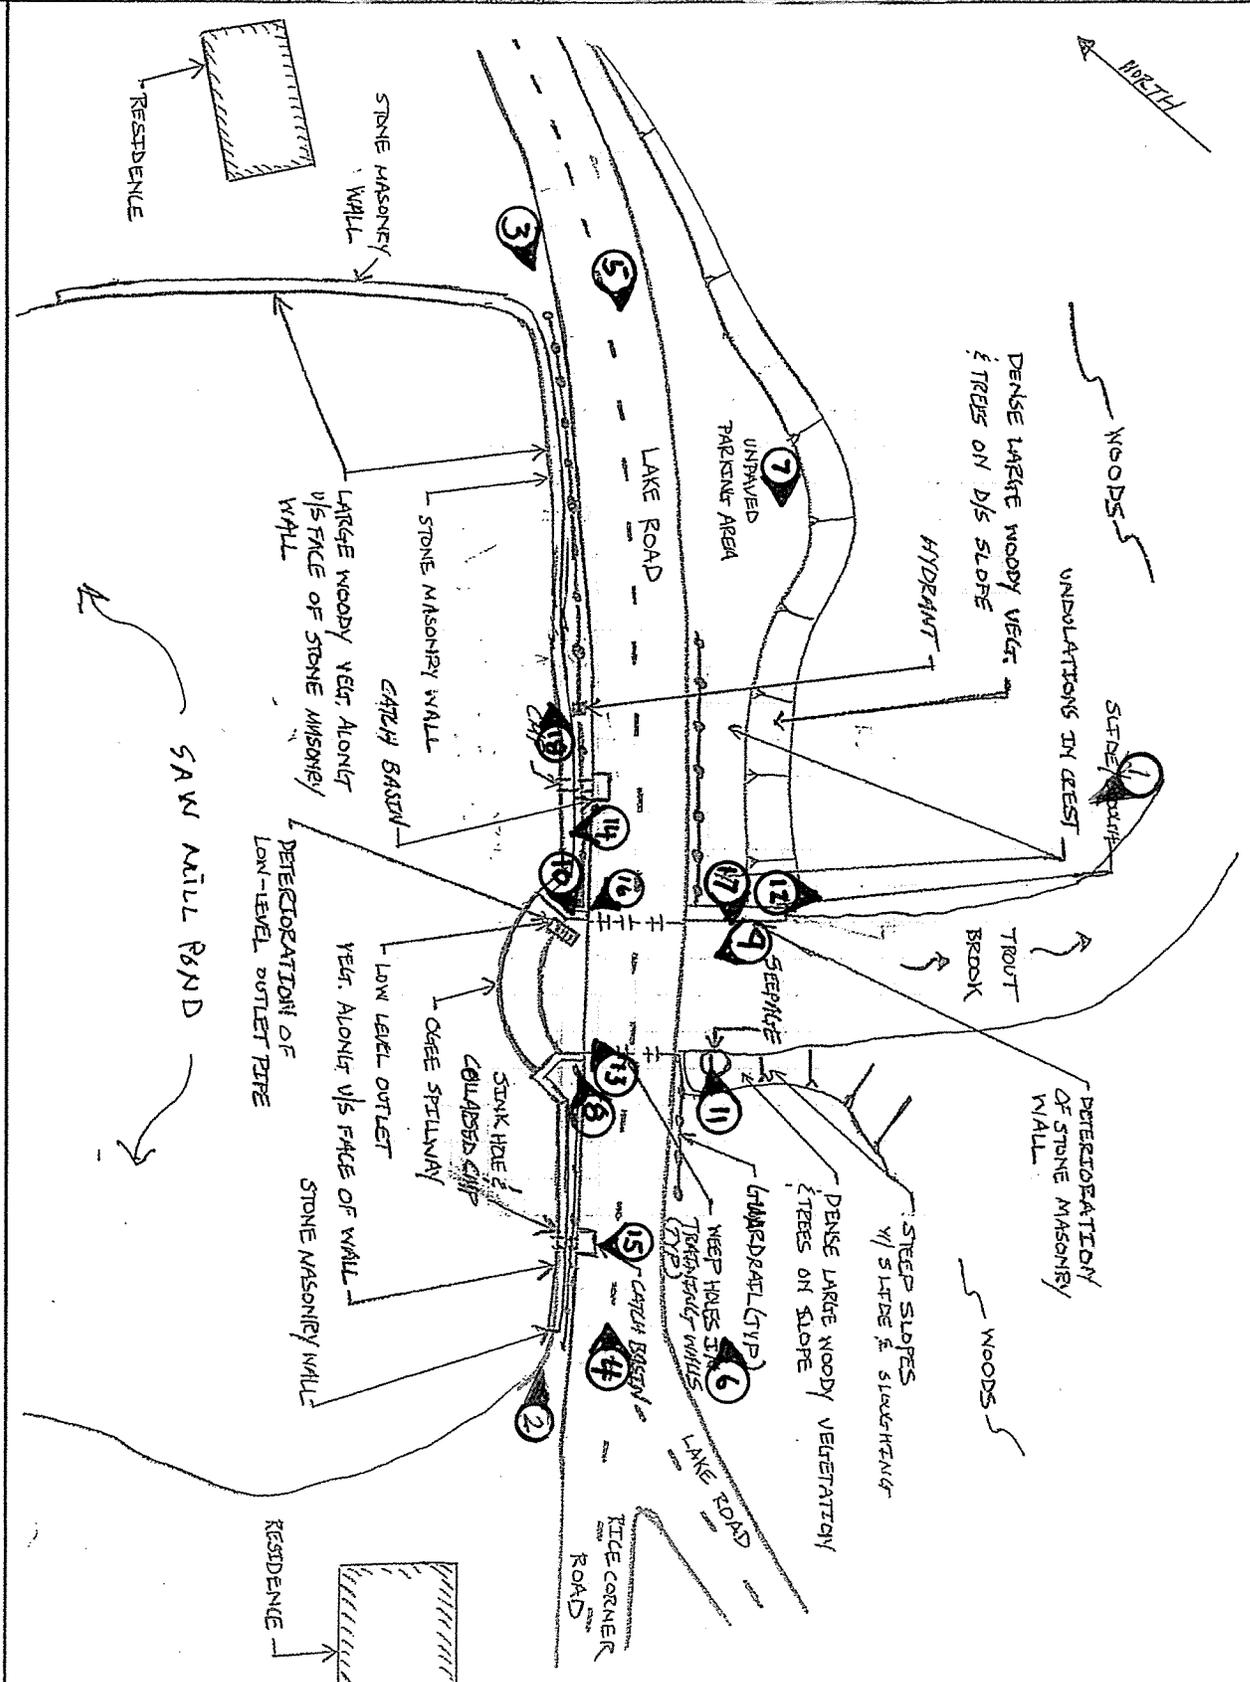
PHOTO LOCATIONS

- **Updated Site Sketch with Photo Locations:**
An updated site sketch with photo locations is attached.
- **Updated Photos:**
Updated photographs of the dam are attached.

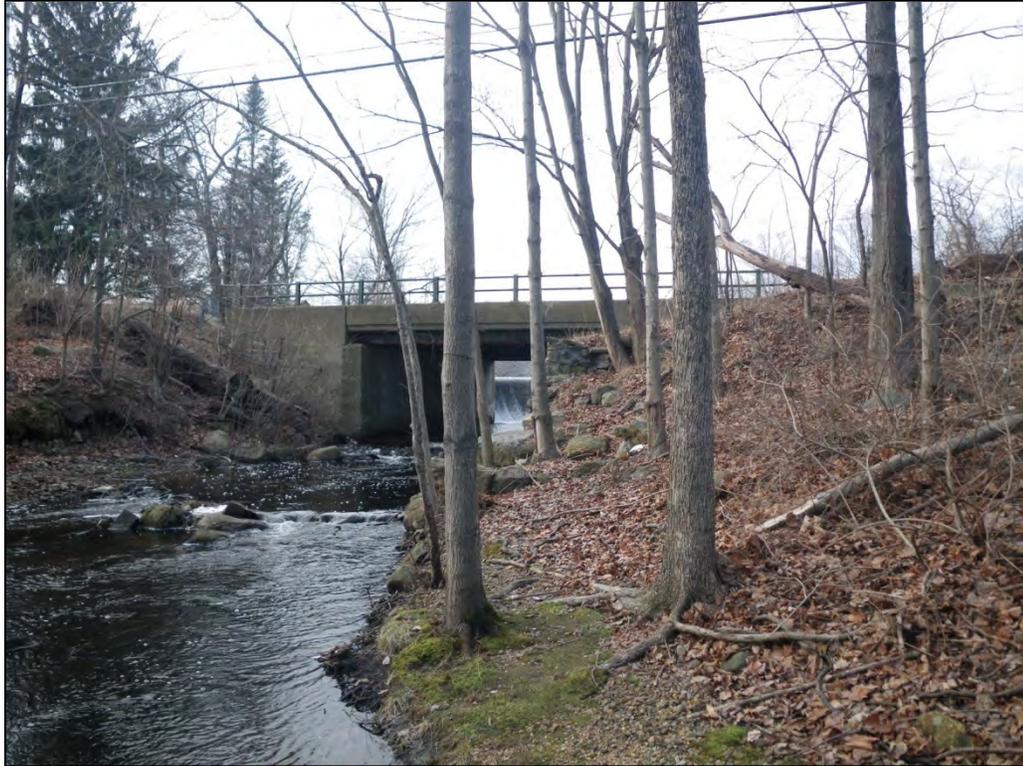
Photo 1: Overview of dam from downstream

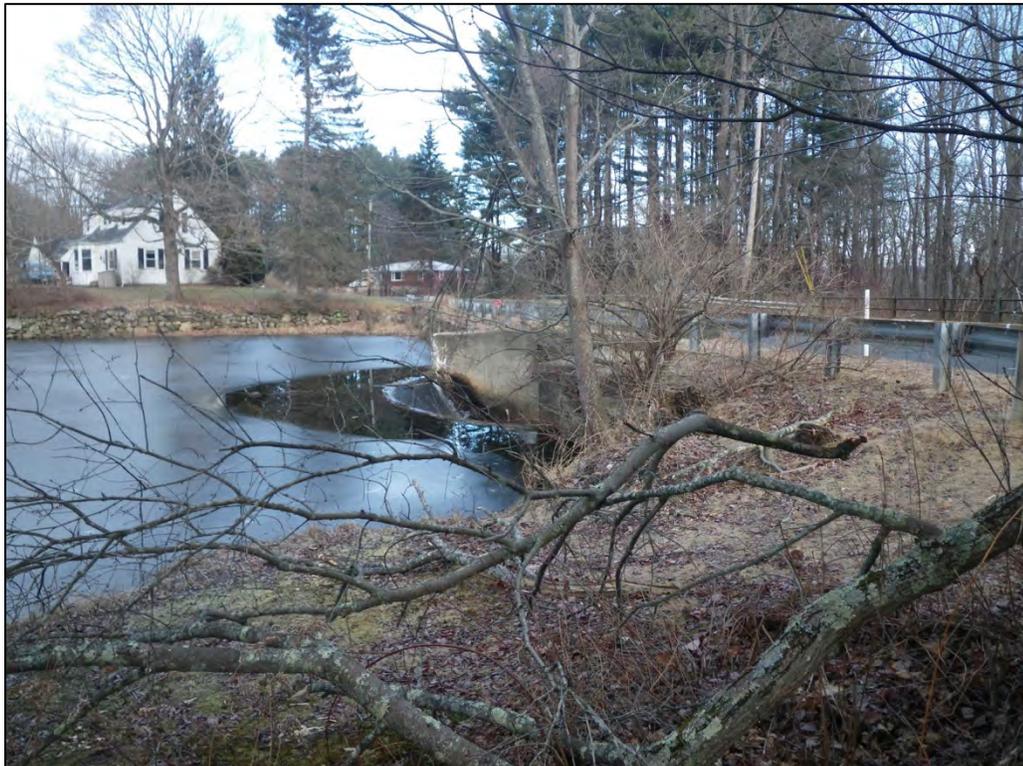
Photo 2: Overview of upstream face from right abutment

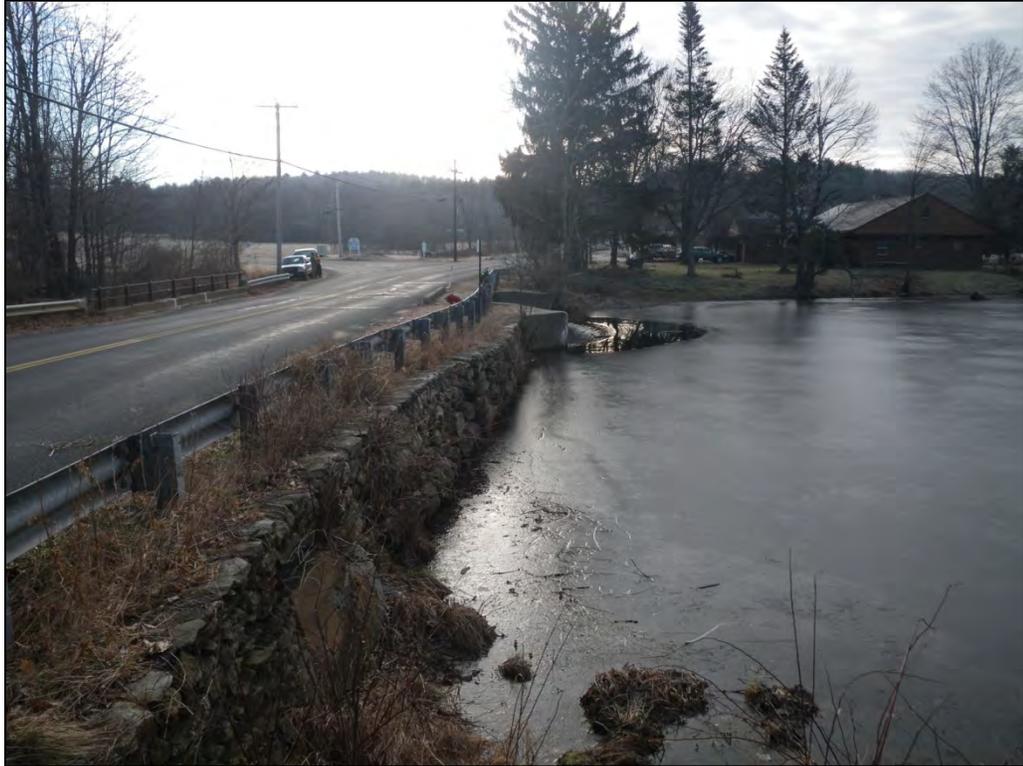
Photo 3: Overview of upstream face from left abutment

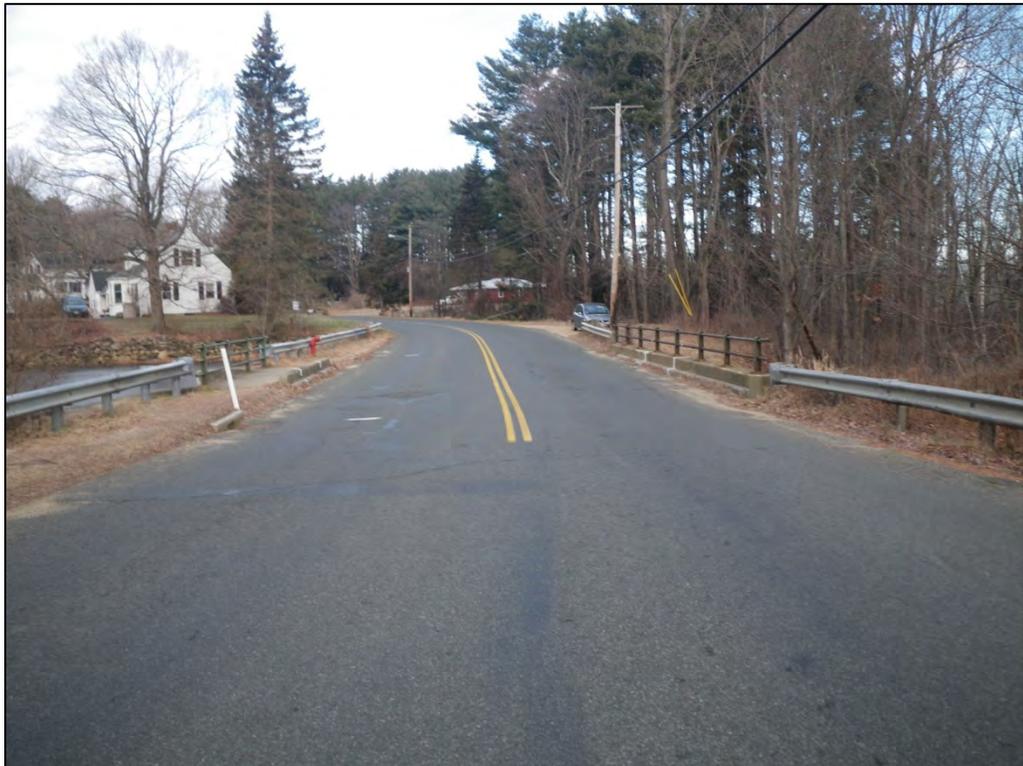
Photo 4: Overview of dam crest from right abutment

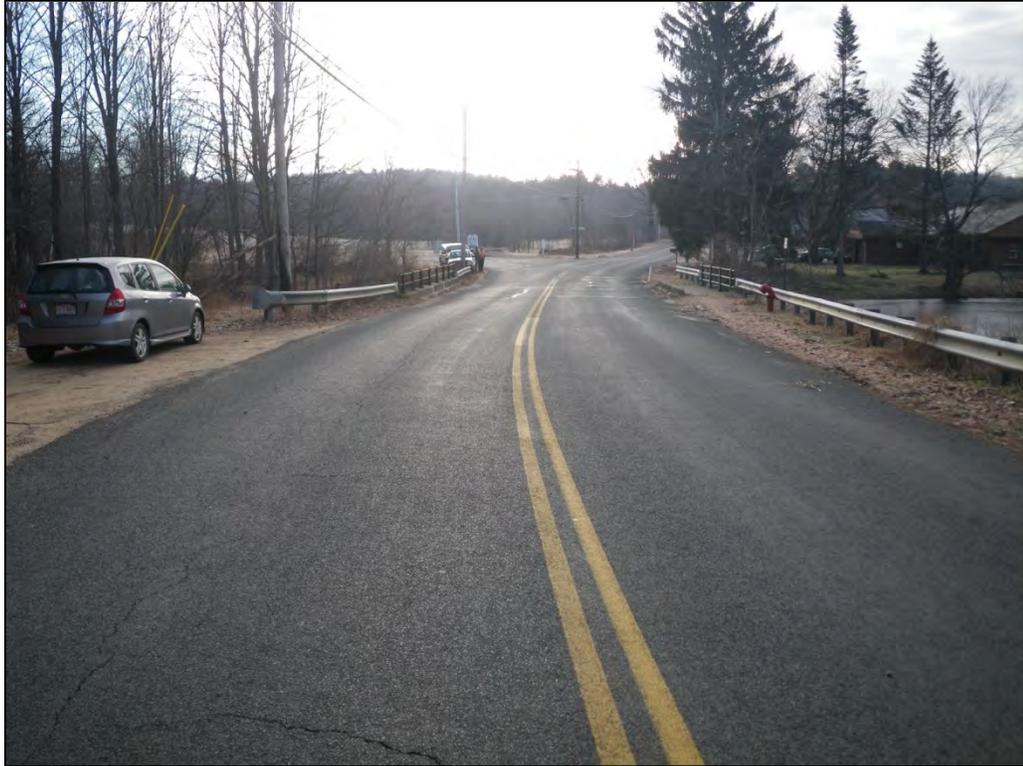
Photo 5: Overview of dam crest from left abutment

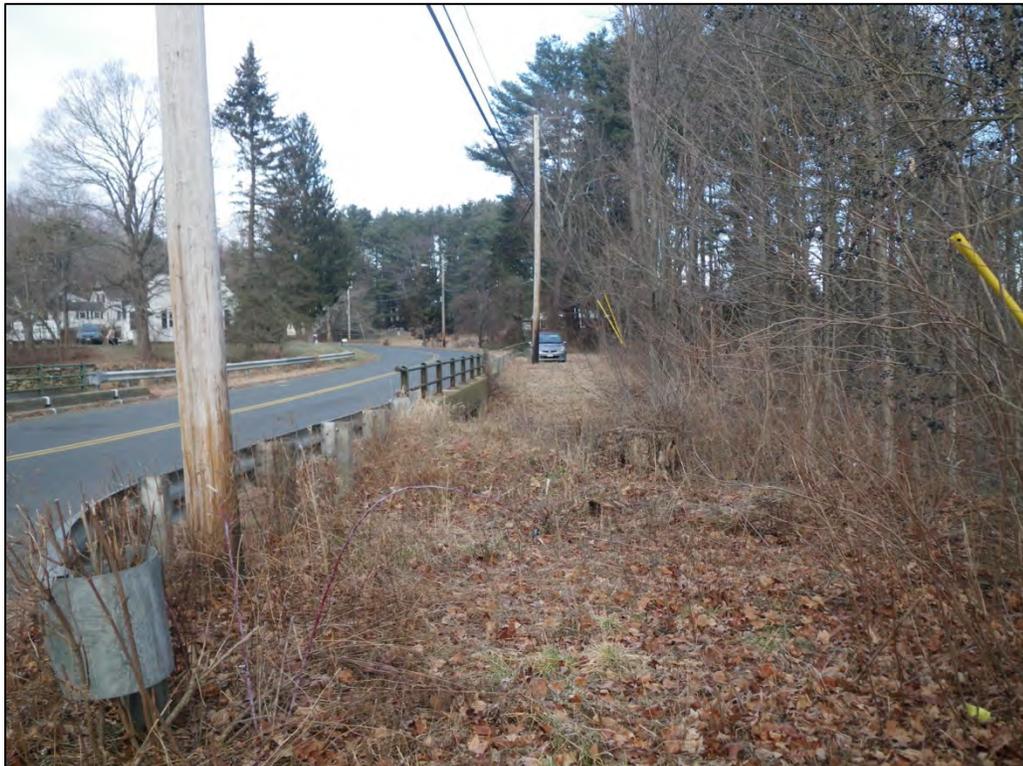
Photo 6: Overview of downstream face from right abutment

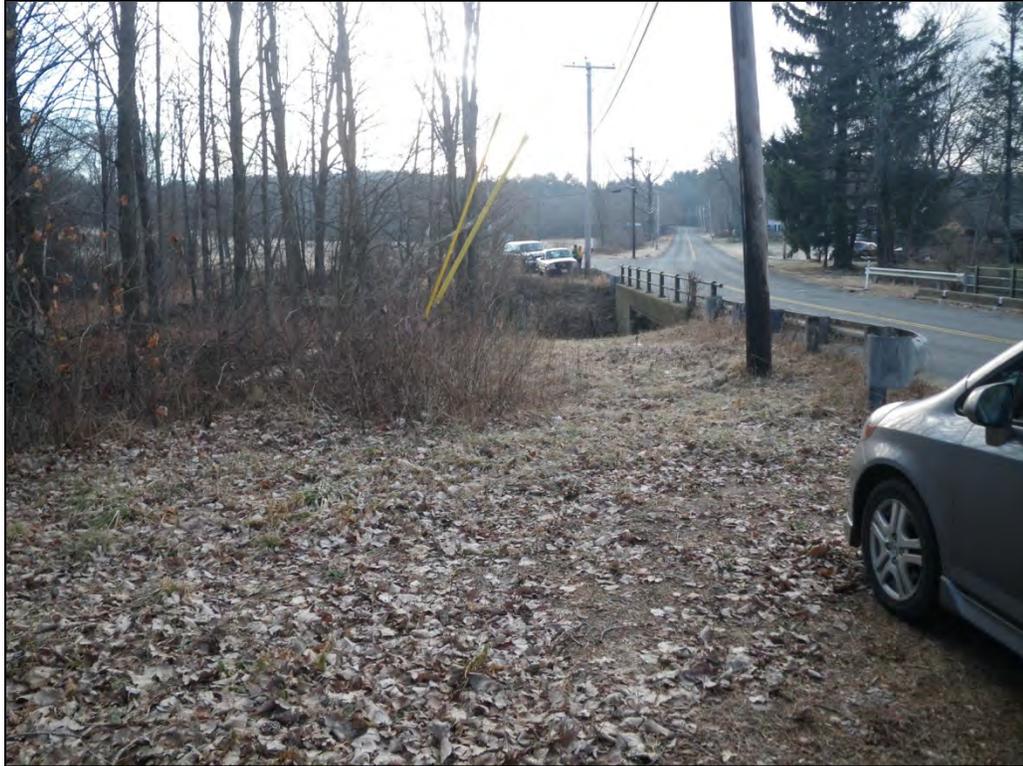
Photo 7: Overview of downstream face from left abutment

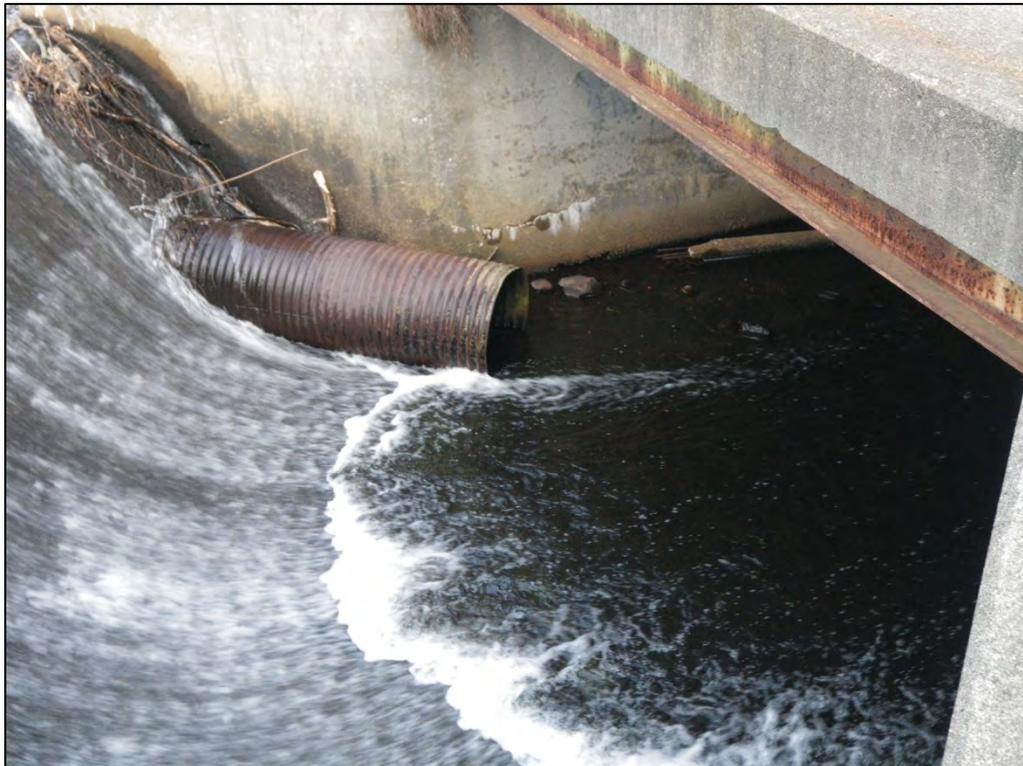
Photo 8: Overview of spillway from upstream

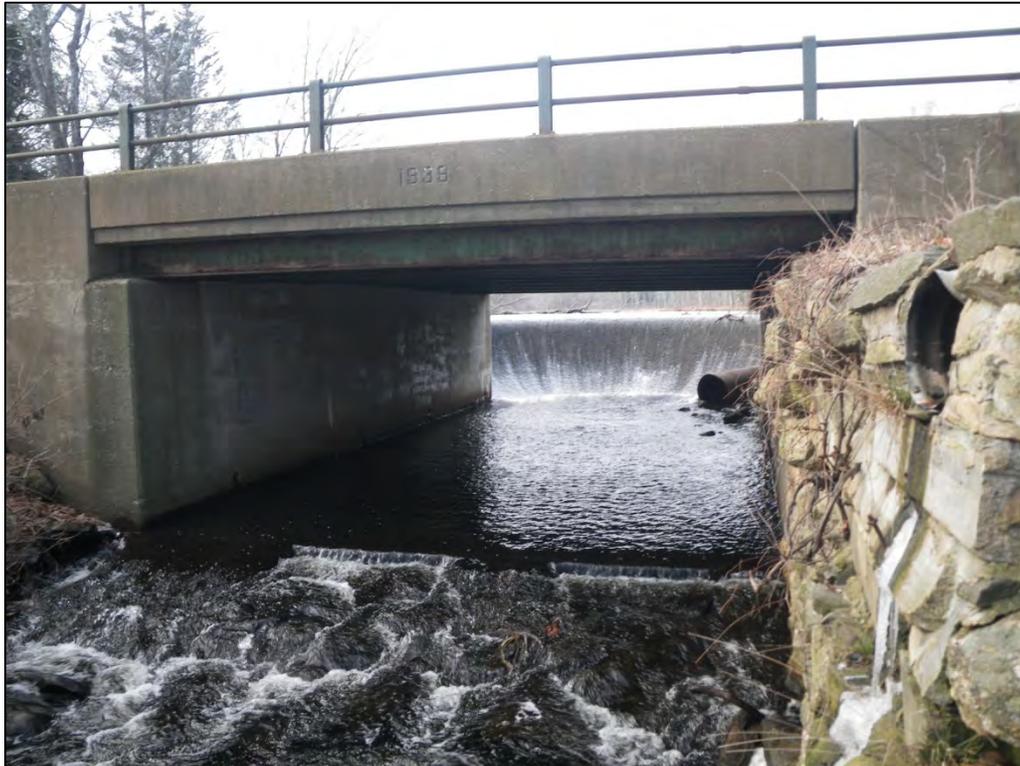
Photo 9: Overview of spillway from downstream (tailrace or channel area)

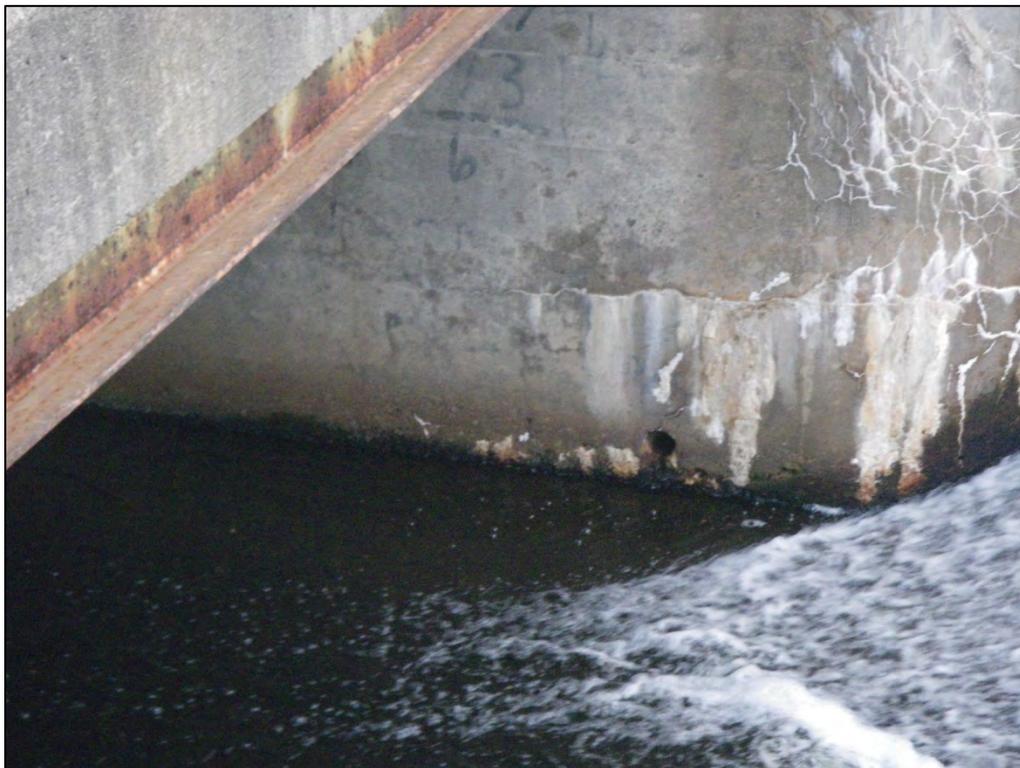
Photo 10: Overview of right training wall

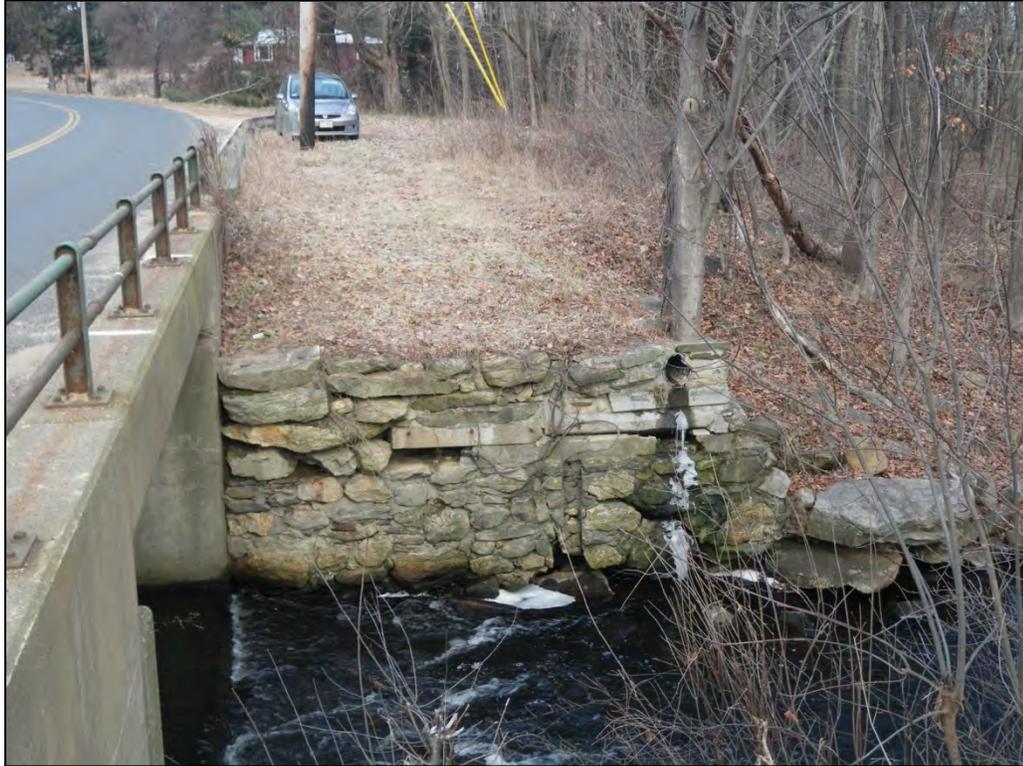
- a. Trees, woody vegetation on dam and abutments.
 - b. Low level outlet pipe severely deteriorated.
 - c. Downstream masonry wall missing base stones.
 - d. Sinkhole with soil loss from the dam embankment above CMP pipe in dam.
 - e. Erosion of downstream right channel.

Photo 11: Overview of left training wall-voids at base, trees on abutment

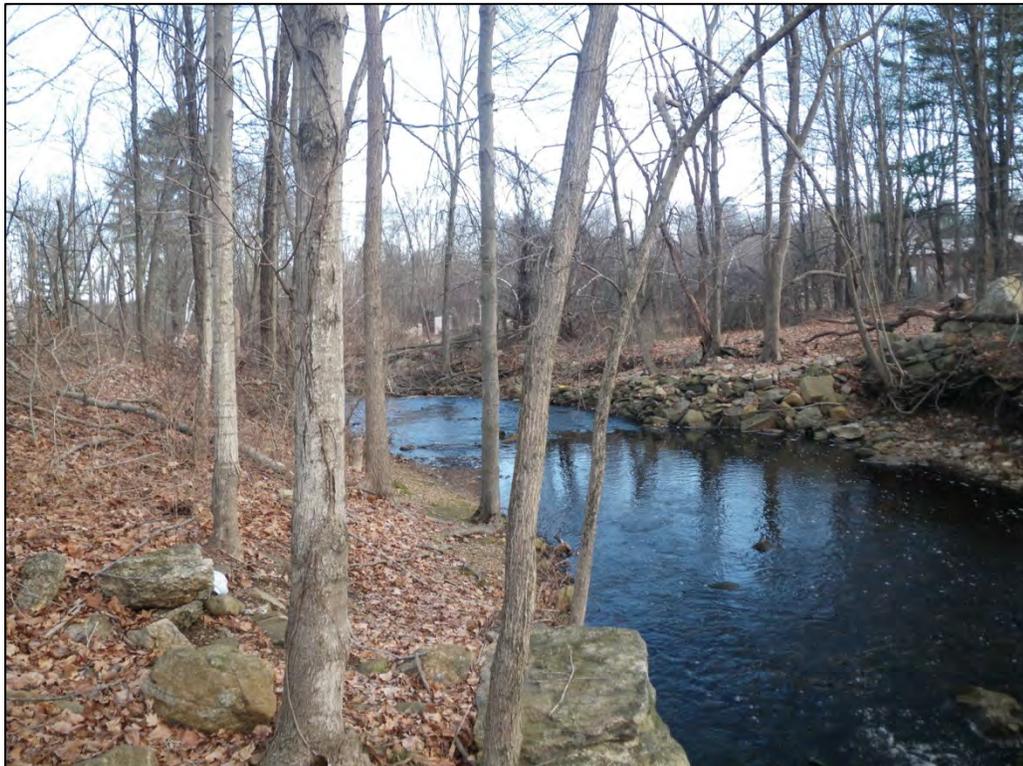
Photo 12: Overview of downstream channel

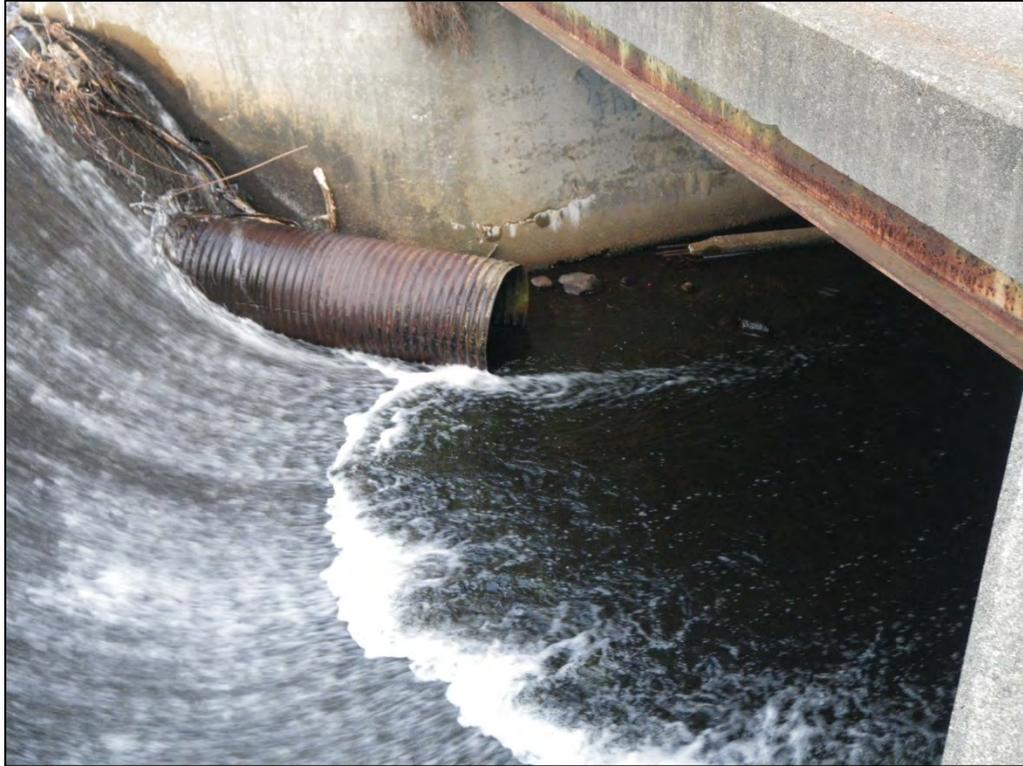
Photo 13: Outlet inlets and discharge points

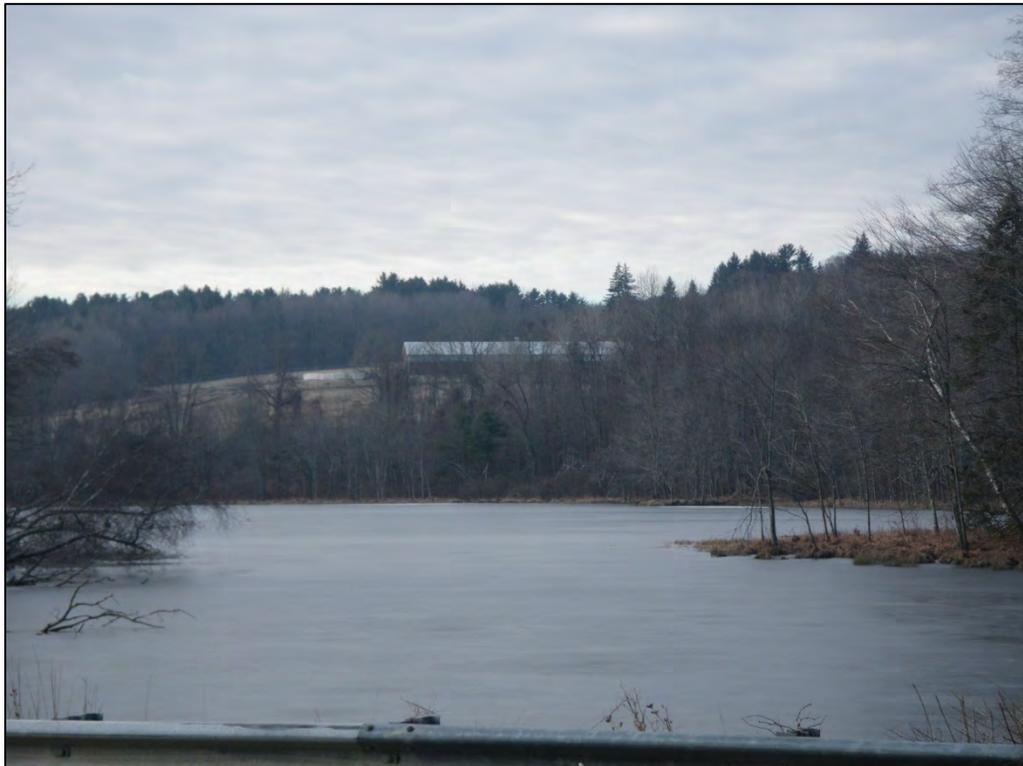
Photo 14: Overview of reservoir

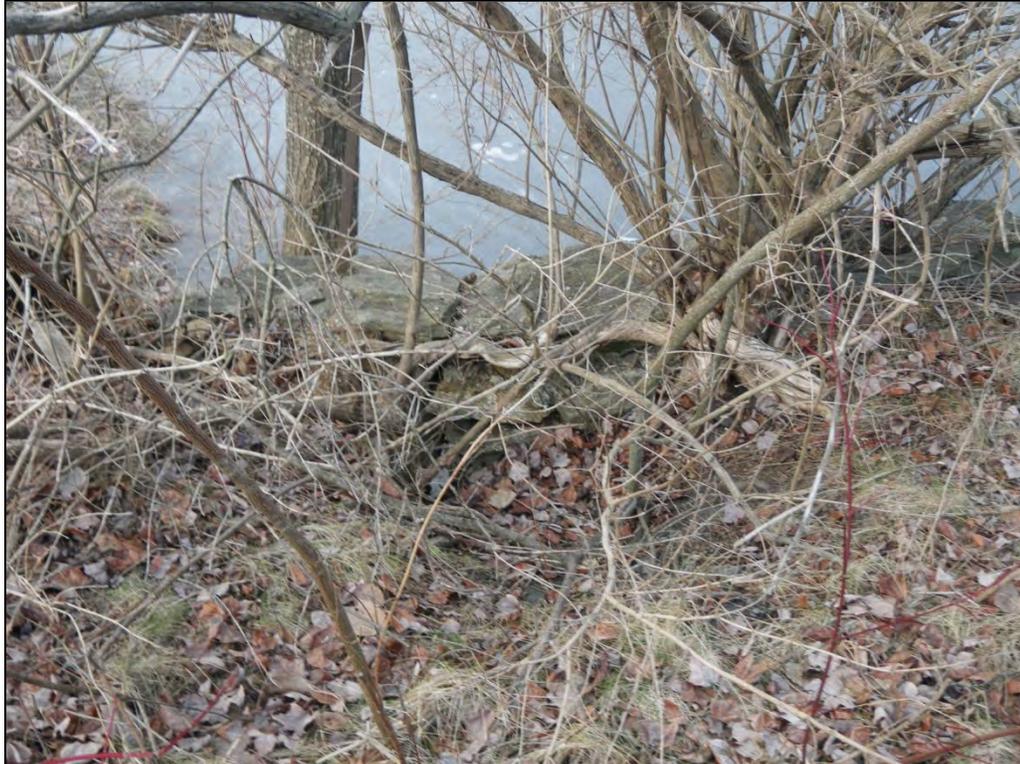
- h) Sinkhole on the crest of the dam over a deteriorated road drainage CMP (Road drainage Corrugated Metal Pipes (CMPs) are located within the dam embankment).

Photo 15: Areas of specific deficiencies-Sinkhole over CMP

- A detailed structural stability analysis should be performed for the embankment and non-embankment portions of this Dam.
 - Remove road drainage CMPs from the dam embankment and repair sinkhole.

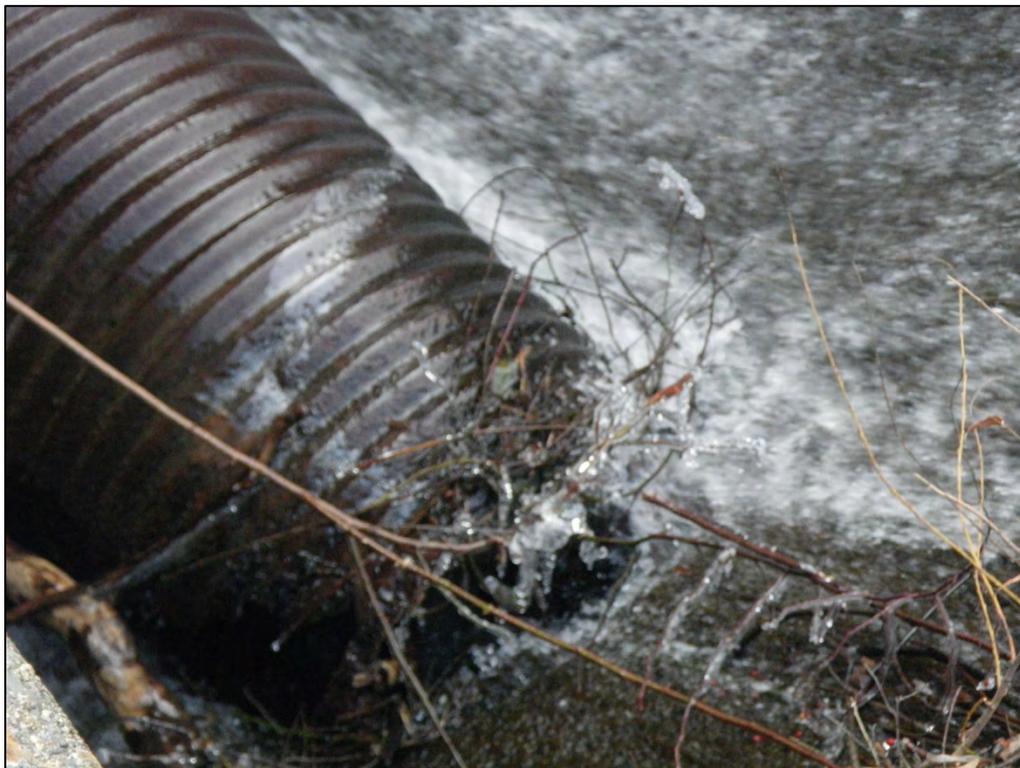
Photo 16: Areas of specific deficiencies-Low level outlet pipe rusted through

- Replace the low-level outlet.
 - Remove woody vegetation from dam embankment and the downstream area within 20 feet of the dam toe.
 - Remove trees and vegetation from upstream stone masonry walls.

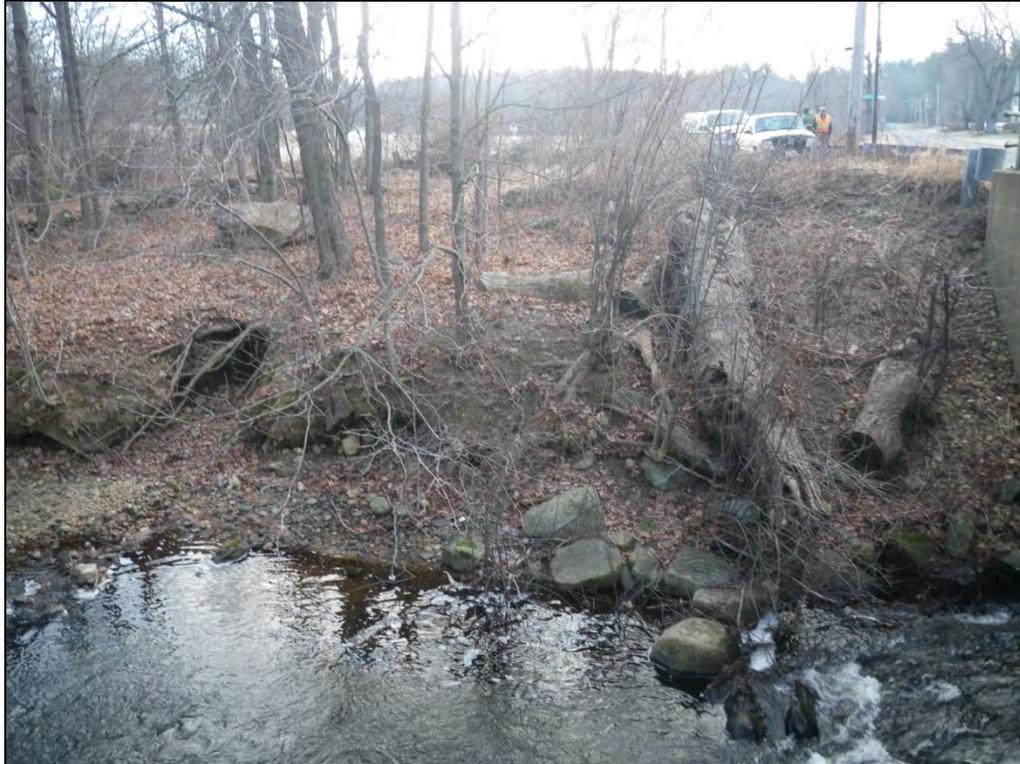
Photo 17: Areas of specific deficiencies-Trees, erosion on right embankment

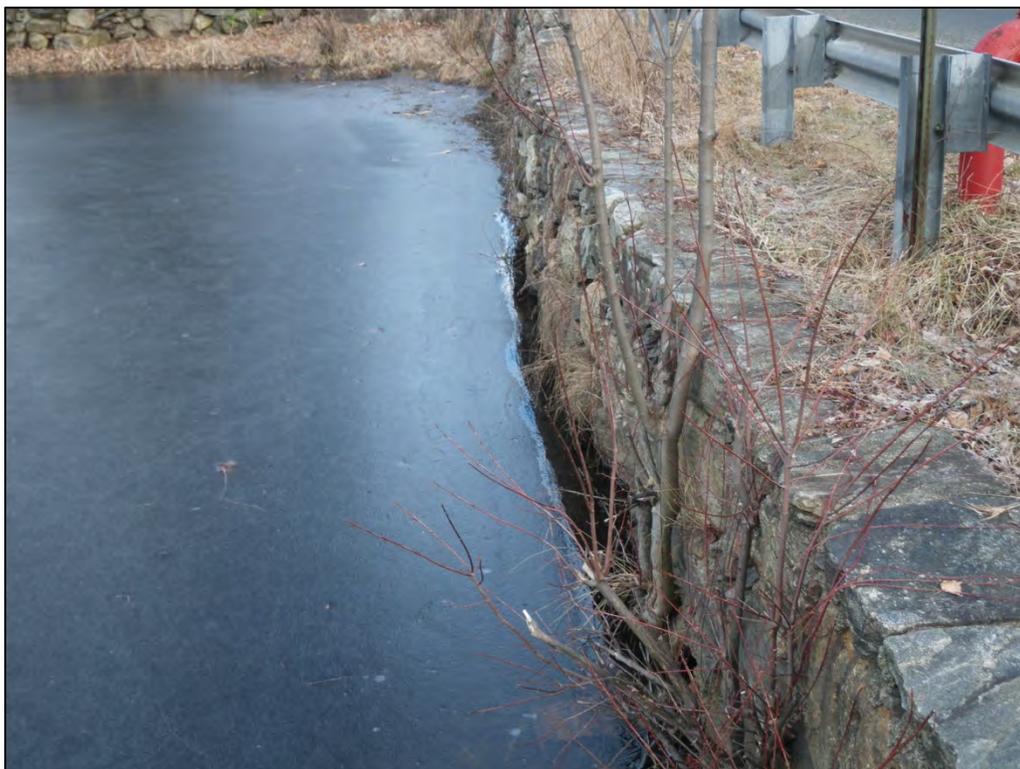
- f) Deteriorated downstream stone masonry wall, including formation of cracks and undermining of the toe.
 - g) Vegetation growing from cracks in the upstream stone masonry walls.

Photo 18: Areas of specific deficiencies-Trees growing from wall
