--SAWMILL POND DAM --
PHASE I
INSPECTION / EVALUATION REPORT

Dam Name: SAWMILL POND DAM
National ID No.: MA00098
Owner: TOWN OF BROOKFIELD, MA
Town: BROOKFIELD, MA
Consultant: LENARD ENGINEERING, INC.
Date of Inspection: JULY 20, 2021

EXECUTIVE SUMMARY

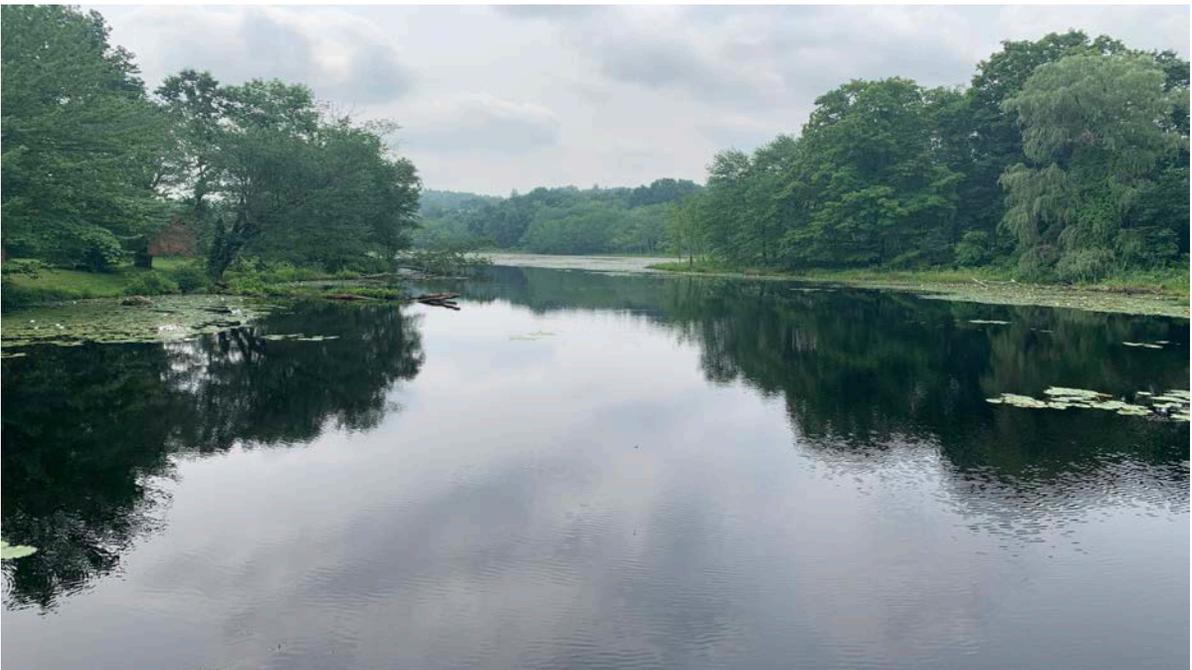
and southeast quadrant of the watershed. Sawmill Pond is a public pond used for recreation. An aerial photograph is shown in Figure 2. See Photograph 16.

Photograph 16: Sawmill/Rice Pond.
